### Porsche Mobile Charger Plus Supply Cable Initialization Failure

#### Vehicles Affected

#### Condition

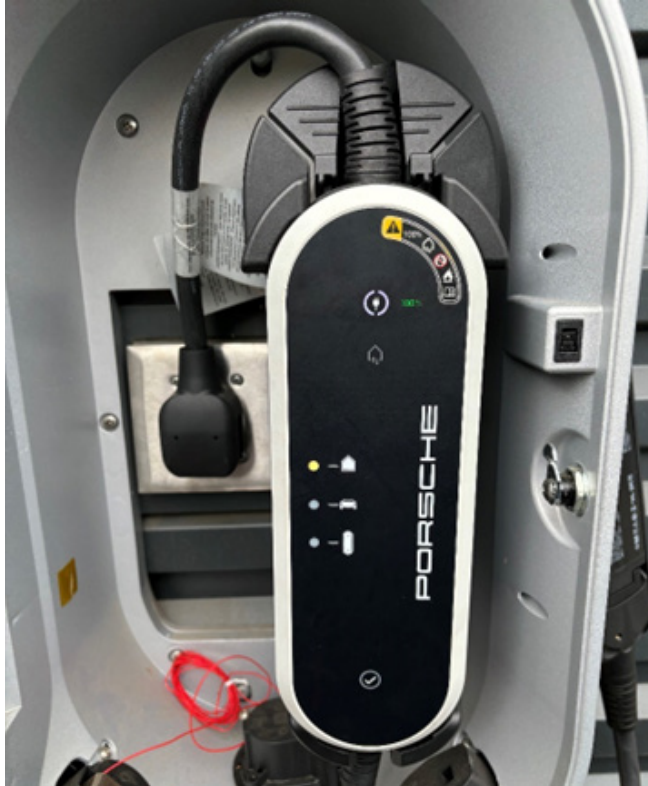
Figure 1

Phase 1: (~20 seconds)

The uppermost Charge Status LED illuminates solid white, while the top "House" LED will illuminate solid yellow for a few seconds as shown in figure 1.

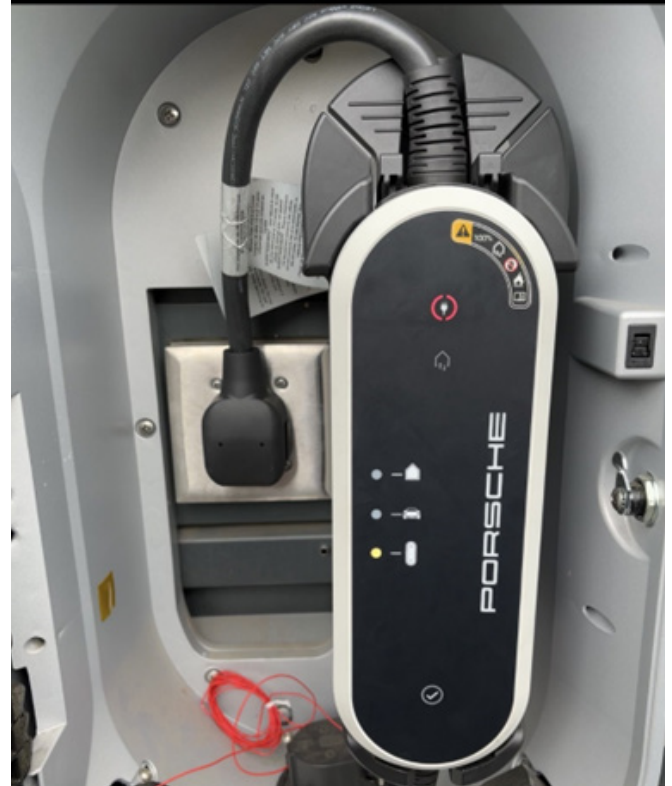
Figure 2

Phase 2: (indefinite)

The uppermost Charge Status LED illuminates solid red, and the bottom "Charger" icon LED flashes yellow as shown in figure 2 as long the unit remains plugged into an outlet.

The inability to read the infrastructure cable is currently understood to be an internal defect due to the sensitivity of the PMC+/PMCC software with some NEMA cables. Association between a functioning and non-functioning cable is currently random with regard to Porsche Mobile Charger.

While the Operating Instructions recommend removing and reinserting the power plug, this does not always remedy the condition. There is currently no known correlation of this condition to supply cable production date. If a charger exhibits the described behavior with a particular supply cable, normal operation cannot be guaranteed with a power supply cable of later production date. Each cable must be physically tested with the customer's charger at the Porsche Center to confirm functionality before returning the updated charger and new supply cable to the customer.

This condition is not directly a fault of the temperature-sensing supply cable. New cables that do not work on the affected PMC+/PMCC devices demonstrating this condition can work normally on PMC Basic part number variants with updated software. If the customer PMC+/PMCC continues to display this behavior with at least 5 replacement supply cables after multiple outlet plug-in cycles, it should be replaced.

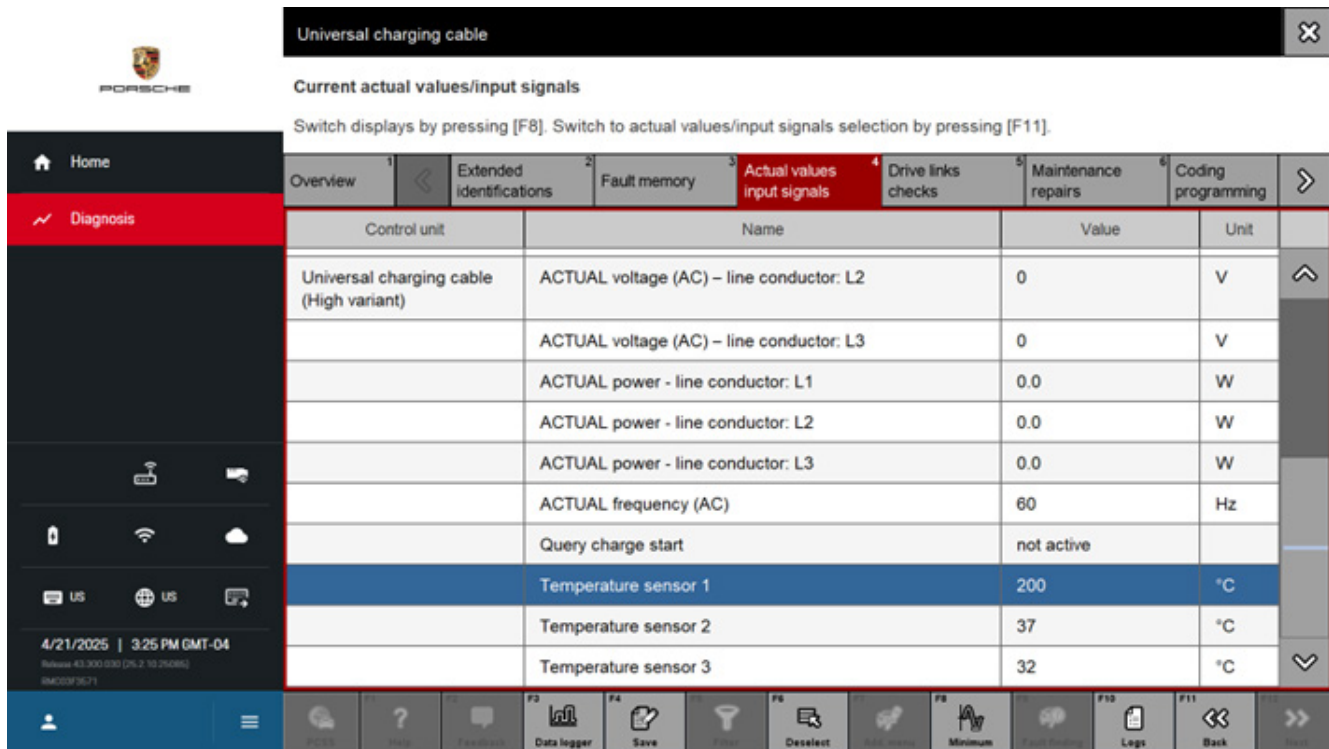
Figure 5

When connecting a Porsche Mobile Charger to the PIWIS tester for diagnostics, one of the temperature sensors in the Actual Values menu is always shown implausible at 200 °C as in Figure 5, regardless of which infrastructure cable is connected. This should NOT be used to diagnose a faulty infrastructure cable without the condition previously described in this case.
