Lack of Cooling Power or Air-Conditioning System Failure - Fault Memory Entry "B16A284" / "B16A384": Observe Procedure for Air Conditioning Testing (54/25)

Model Line: **Taycan (Y1A / Y1B / Y1C)**

Model Year: **As of 2020**

Concerns: **Air-conditioning system**

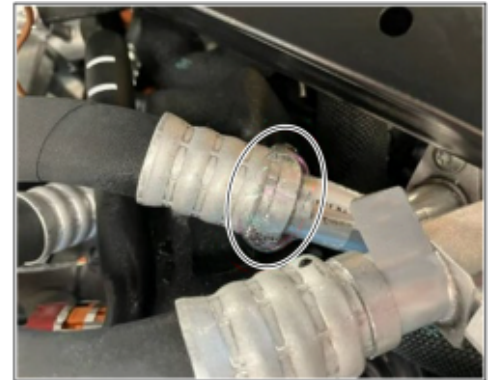
Example of a leak on pressing with alkali/soapy water

The leak test of the air-conditioning system must be carried out within the framework of this Technical Information using alkali/soapy water on all refrigerant-carrying components of the air-conditioning system. ⇒ Example of a leak on pressing with alkali/soapy water

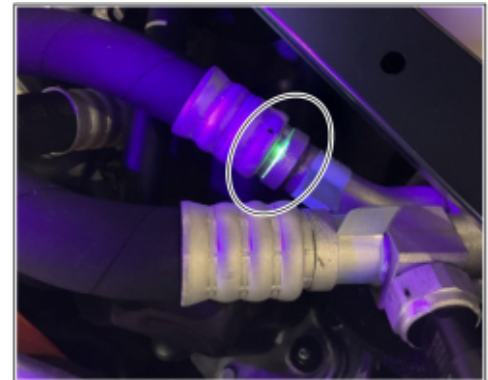
Example of a leak on pressing with leak detection additive

Please follow the correct sequence for this and do not
⇒ Example of a leak on pressing with leak detection additive start immediately with the leak detection additives.
