This Service Information Bulletin (Revision 2) replaces SI B51 22 24 **dated January 2025**.

- SIB 51 22 24 - Main Door Seal Detaching at the Sealing Joint.

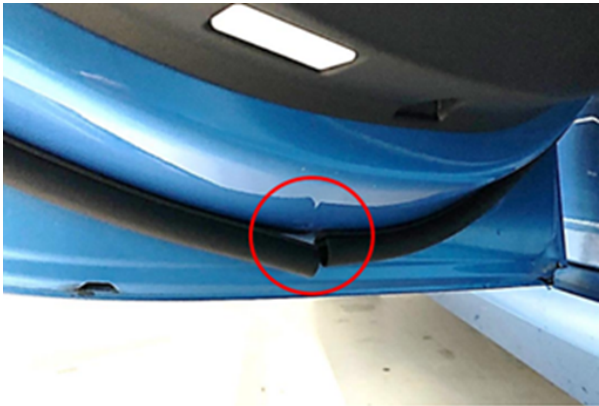
On the main door seal, detachment behavior can be detected in the sealing joint area.

Overtime, the sealing material continues to detach more and more, which can cause the seal to dangle and become visible to the customer.

Contamination of the surface onto which the door seal bonds/adheres.

Partially replace the affected main door seal.

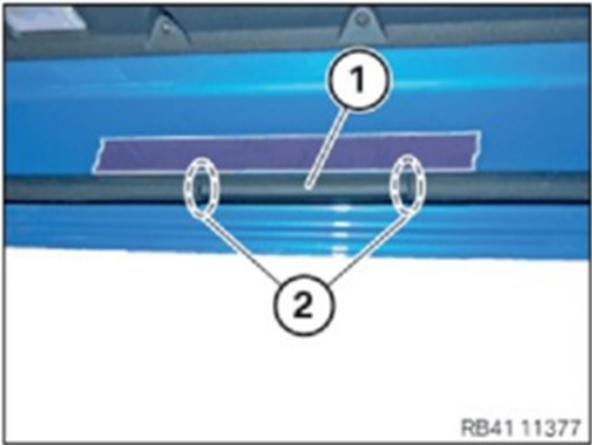
2. For these cases, where the main door seal detaches in the area that it is not visible to the customer (shown above), repair the detached portion of the main door seal by replacing the affected section by following the repair instructions listed in ISTA/AIR 51 71 003.

**Note: The complete replacement of the main door seal(s) is not permitted for the issue described in this Service Information Bulletin.**
