## WSG2 - Re-Code Thermal Management Control Unit (Workshop Campaign)

**Model Year:** **As of 2025 up to 2026**

**Model Line:** **Panamera E-Hybrid (YAA / YAB)**

**Concerns:** **Thermal management control unit**

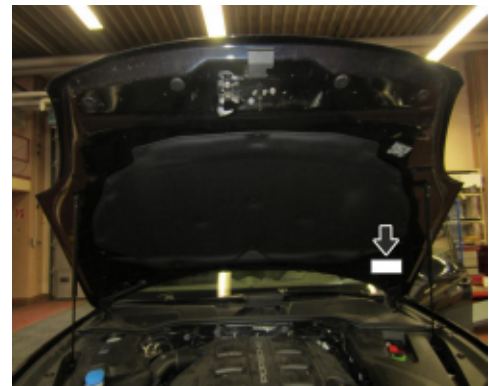
*Proof of Completion Label: specified position (Exemplary illustration)*

- 5.1 Fill out the Recall Proof of Completion label  
⇒ *Recall Proof of Completion Label* fully and correctly. This includes the recall code "WSG2", your Porsche Center code and the repair date.
- 5.2 Clean the surface in the lower area on the front lid at the left-hand side in direction of travel at which the Recall Proof of Completion label must be attached ⇒ *Proof of Completion Label: specified position (Exemplary illustration) -arrow-* using a suitable cleaning agent and a clean, grease-free and lint-free cloth.
- 5.3 Affix Recall Proof of Completion label in the lower area of the front lid at the lefthand side in direction of travel ⇒ *Proof of Completion Label: specified position (Exemplary illustration) -arrow-*.
- 5.4 Close front lid.
- 6 Enter campaign in the Warranty and Maintenance logbook.
