Service Bulletin

Bulletin No.: 25-NA-117

Subject: Click or Tick Noise Coming from the Heads Up Display or Upper IP Area

Brand:	Model:	Model Year:		VIN:		Engine:	Transmission:
		from	to	from	to		
Cadillac	Escalade Models	2025	2025	-	-	All	All
	Escalade IQ

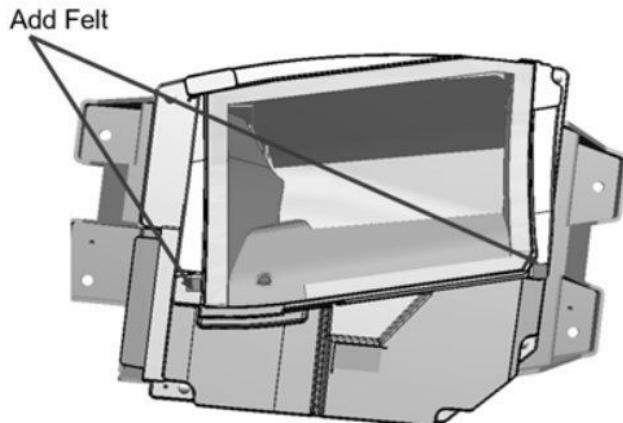
6925112

Involved Region or Country	North America
Condition	Some customers may comment on an itch, click, or tick noise coming from the Heads-Up Display (HUD) area over various road surfaces.
Cause	The cause of the condition may be interference between the HUD and IP Trim Panel extension.
Correction	Install felt tape to the HUD housing in the locations shown below. Note: Only apply the felt tape to the two locations shown below.

2. Install 2 pieces of felt roughly 10mm x 10mm x 3mm in the locations shown above.
3. Reinstall the Instrument Panel Extension. Refer to *Instrument Panel Extension Replacement* in Si.
