# Technical Service Bulletin

## TSB102

**Purpose:** There is a possible condition where the exterior entrance door handle mechanism can bypass the inside linkage causing a lock-out situation whereby the door cannot be opened from the exterior handle.

**TriMark Corporation 030-0900 Motor Home Entrance Door Hardware**

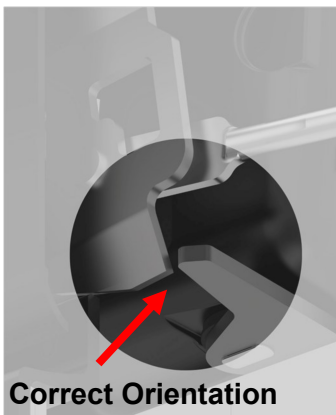
Correct Orientation

**Step 11a:** Lift the interior handle to make sure the system is seated properly, and the outside driving cam is behind the inside pivot plate, while pressing the inside and outside together.
