Dynamic or Park Camera Push Button Switch In The Lower Control Panel (LCP) Is Stuck or Inoperative

Topic number	LI54.25-P-079602
Version	1
Function group	54.25 - Switches
Date	9/3/25
Validity	GLA/GLB + CLA as from modification year 23/1 (804)
Reason for change

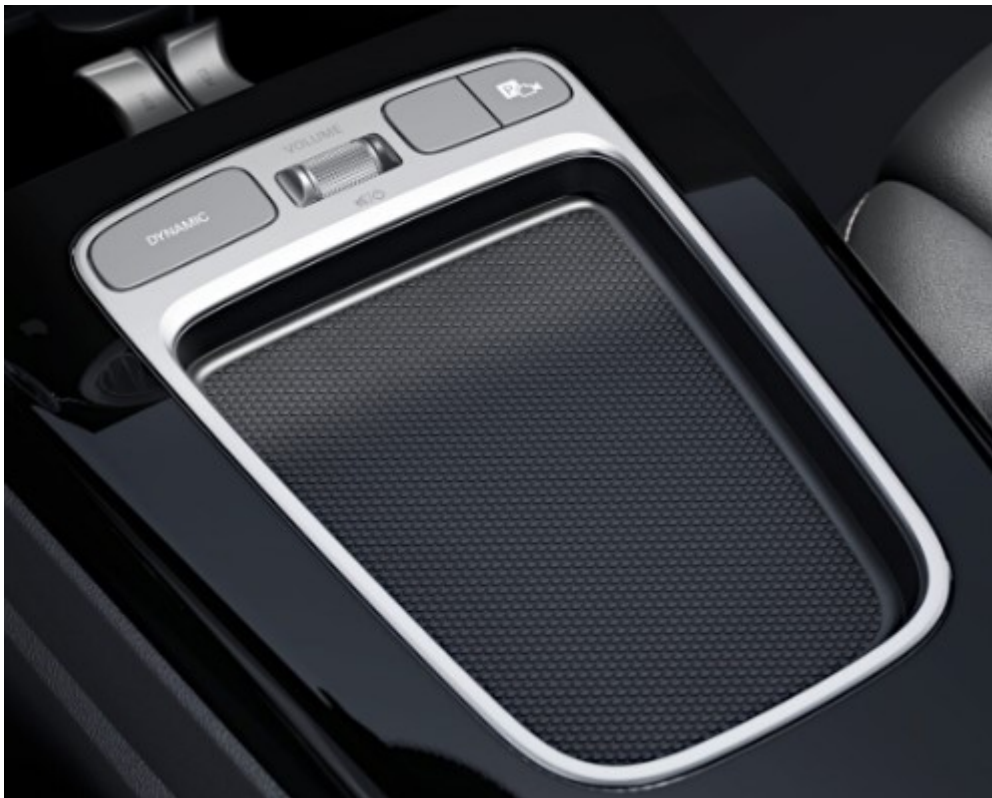
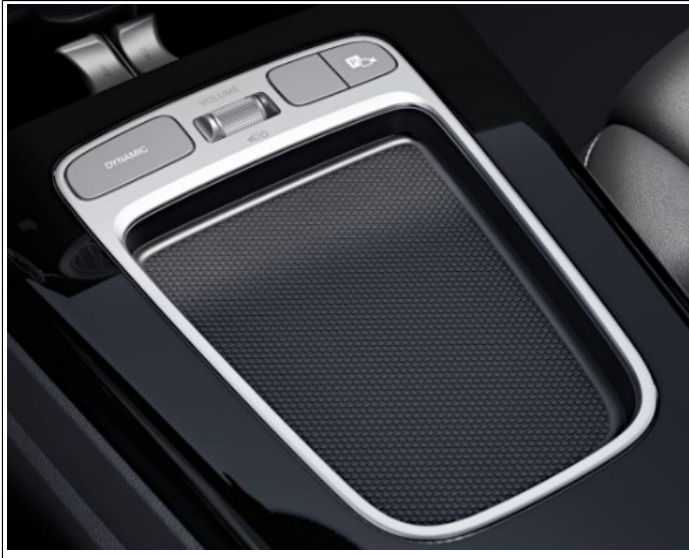
Attachments	
File	Description
01.jpg	Lower control panel

The Dynamic or Park Camera button in the LCP is stuck or does not react.

In rare cases, tension between the component parts of the LCP and trim of the center console could result in the buttons sticking.

Remove LCP and reinstall while ensuring it is free of any tension. Replacement is not necessary.
