Failure of One or More Surround View Cameras in the PCM Central Display

Models	Model Year	Model Type	VIN Range	Vehicle-Specific Equipment
Taycan	2025	Y1A, Y1B, Y1C	All	KA6
Panamera	2025	YAA, YAB	All	KA6
Cayenne	2025	9YA, 9YB	All	KA6
911	2025	992	All	KA6

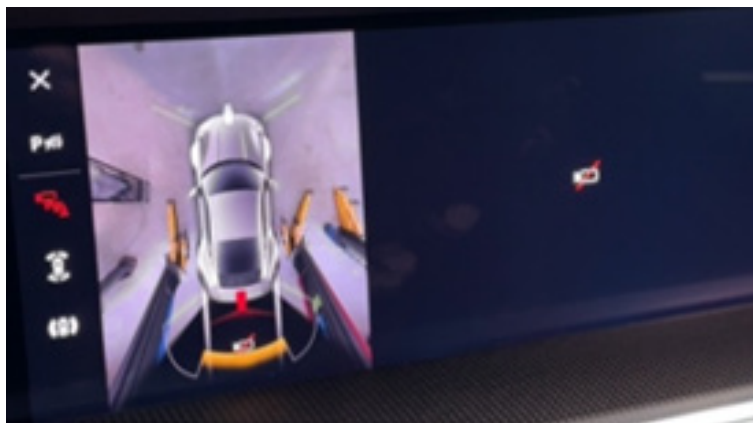
Figure 1

The customer complains about a sporadic, partial, or complete failure of the Surround View in the PCM Central Display. In addition, one or more of the fault memory entries listed below are stored in the control unit for assistance systems.

Update the Assistance System control unit H11 to software version 0511 using PIWIS Tester v43.500.030 (or higher).
