Intermittent Warning Message "Power Button Faulty - Service Required" in the Instrument Cluster/Fault Memory Entry "B143C29" in the Rear-End Electronics Control Unit (65/25)

Model Line: **Taycan (Y1A/Y1B/Y1C)**

Model Year: **As of 2020 up to 2025**

Concerns: **Start-stop switch (ignition release switch)**

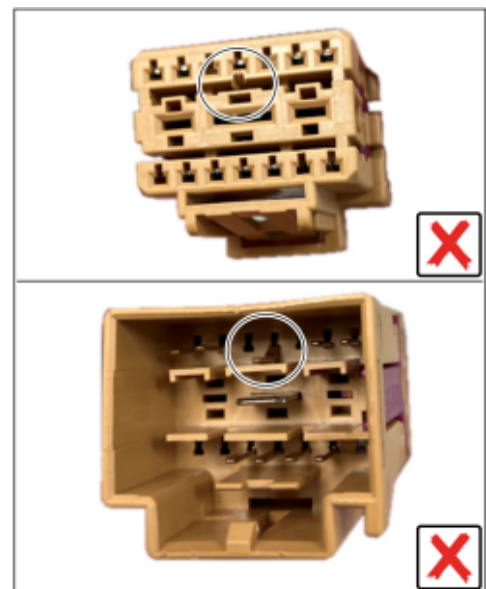
It is possible that pin 4 is bent at the electrical plug connection TCP.R.1A1 (disconnection point) **between the dashboard and main wire harness.**

Bent pin with damaged plug housing

Therefore, before replacing the start-stop switch, the electric plug connection must be checked for bent pins, reworked if necessary or replaced if damaged. ⇒ Bent pin with damaged plug housing
