Oil Leakage in the Area of the Upper Part of the Oil Pan and Crankcase: Checking Return Seal on Upper Part of Oil Pan and Replacing if necessary (91/24)

Vehicle Type: **911 Carrera (992) / 911 Carrera S (992) / 911 Sport (992) / 911 Carrera GTS (992) / 911 Carrera T (992) / 911 Carrera 4 (992) / 911 Carrera 4S (992) / 911 Carrera 4 GTS (992) / 911 Targa 4 (992) / 911 Targa 4S (992) / 911 Targa 4 GTS / 911 Turbo (992) / 911 Turbo S (992) / 911 Dakar (992)**

Model Year: **As of 2020 up to 2024**

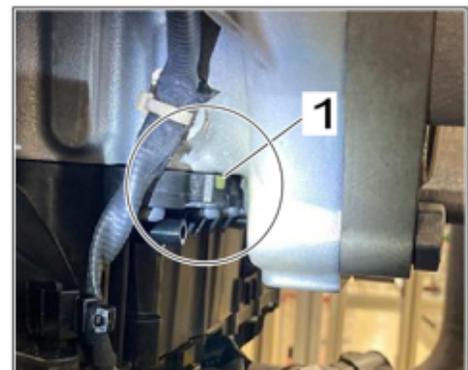
Oil leakage area

Cause: **Oil traces are detected on the oil pan on the side of the engine transmission flange.**

The leak is located in the area of the sealing point between the upper part of the engine oil pan and crankcase ⇒ *Oil leakage area -Circle-*, on green return seal ⇒ *Oil leakage area -1-* in the "window section" of the upper part of the oil pan.

Action: Check the return seal in the area of the "window section" and replace it with a **new component status** if applicable.

Replacing the upper part of the oil pan, including the moulded seal, is not expedient because this complaint involves a defect in the return seal in the area of the "window section" of the oil pan and not a defect in the oil pan itself.

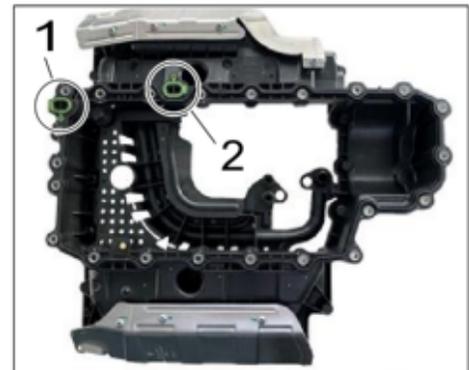
- 3 Replace previous return seals ⇒ *Affected seals -1 and 2-* on the upper part of the oil pan with **new, black return seals with a new component status.**

The previous component status of the return seal in green must no longer be used here.
