## 718 Spyder RS – Convertible Top Warning not fully locked message in Instrument Cluster

**Bulletin #: 2520**

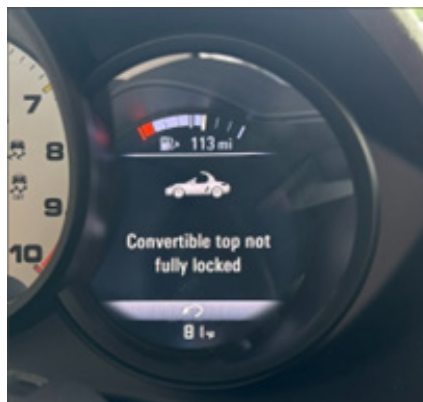
Figure 1

Customer states the instrument cluster displays the message, "Convertible top not fully locked " (Figure 1), or, alternatively, "Convertible top not fully locked | Do not drive on" even though the roof is fully secured in the raised or lowered position according to the instructions in the owner's manual (optional: video instructions).

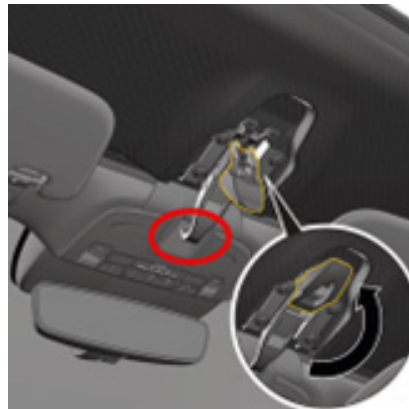
**Figure 2**

One (1) microswitch [S16] in the overhead console informs the BCM Rear of the convertible top locking hook position. The overhead console microswitch is actuated by the interior roof locking hook. (Figure 2)

- Verify the tip of the roof locking hook makes proper contact with the microswitch in the overhead console.
- Verify the switch in the overhead console actuates mechanically and electrically, and that the signal is consistent at the BCM Rear.

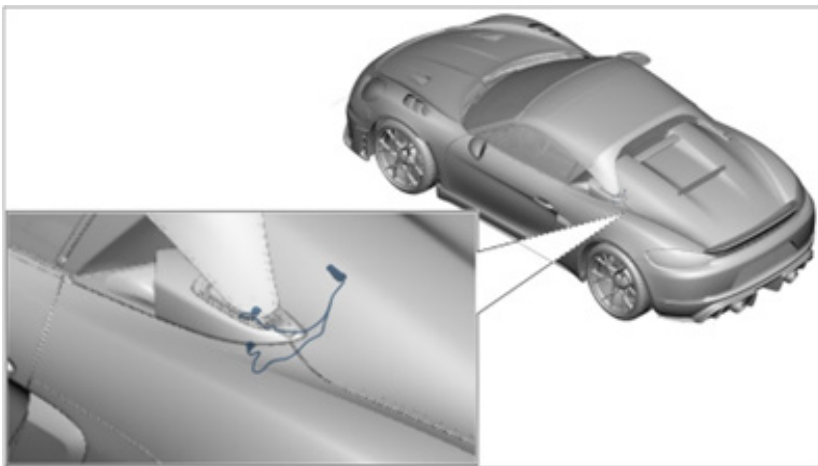
Figure 3

Two (2) microswitches [S20 + S22 (Left) & S21 + S23 (Right)] are located in each of the left and right side roof fin tensioners (Figure 3).

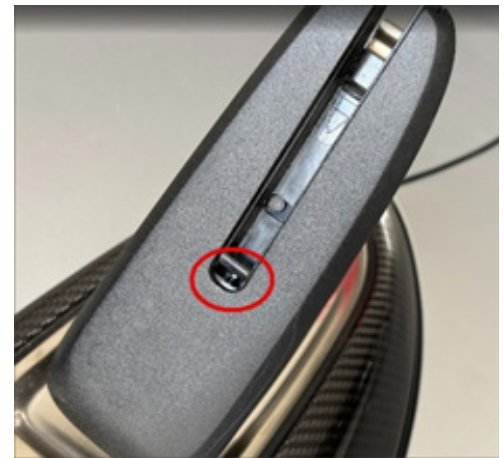
Figure 4

One microswitch on each side detects if the convertible top fin 'striker' is engaged into the latch (Figure 4), and the other microswitch on each side detects when the hinged fin tensioners are latched down.
