The Front Display and Control Panel Flickers or Fails Intermittently (221/24)

Model Line: **Cayenne (9YA / 9YB)**

Model Year: **As of 2024 up to 2025**

Concerns: **Front display and operator control panel**

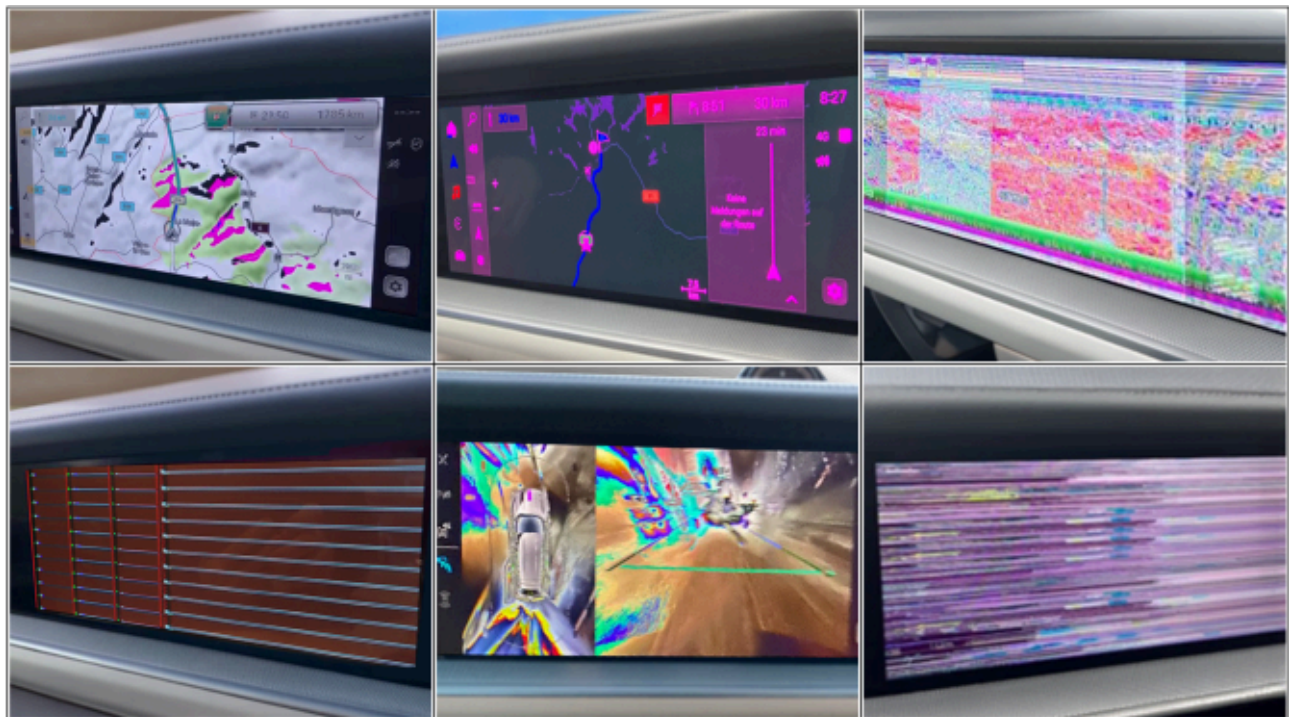
Cause: **The customer complains that the front display and control panel is flickering, fails occasionally or content is displayed in a distorted / divided manner.**

Example illustrations of complaints regarding the front display and control panel

Action: In the event of a customer complaint, re-program the control unit for the PCM central computer (central display and passenger display) using the PIWIS Tester.
