The Front Display and Control Panel Flickers or Fails Intermittently (221/24)

Model Line: **Panamera (YAA / YAB)**

Model Year: **As of 2024 up to 2025**

Concerns: **Front display and operator control panel**

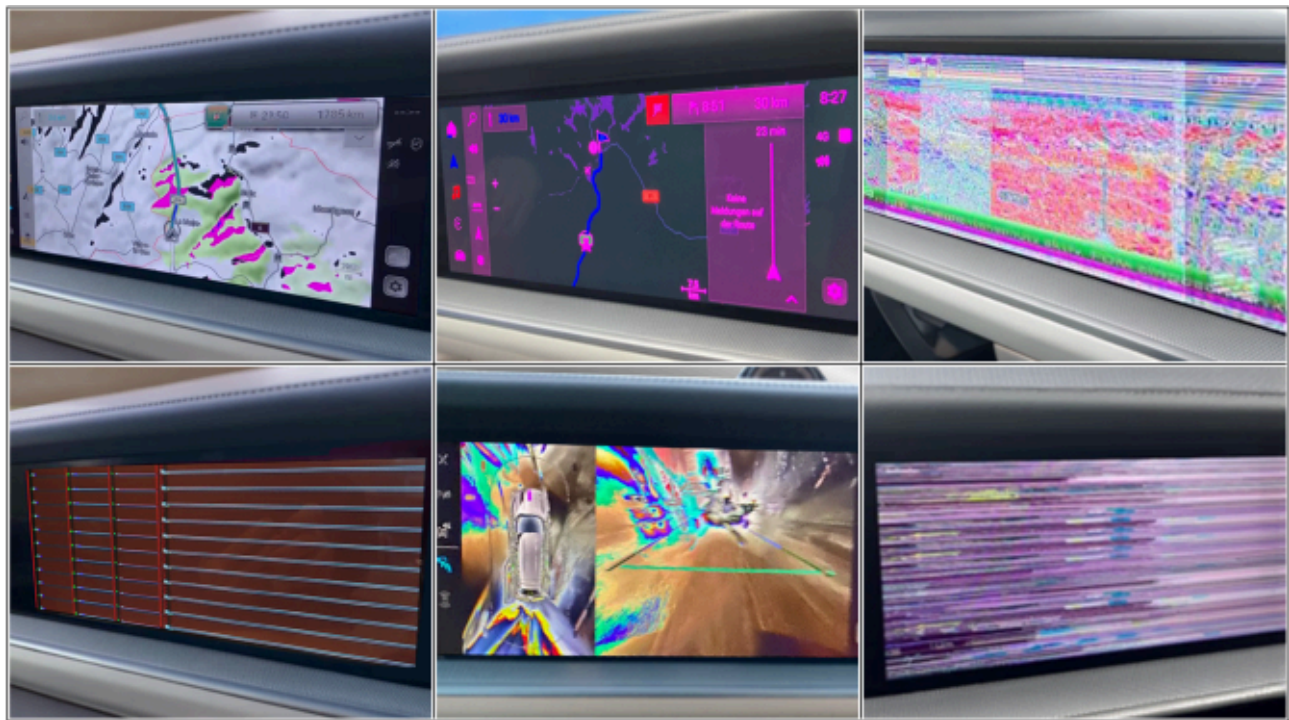
Cause: **The customer complains that the front display and control panel is flickering, fails occasionally or content is displayed in a distorted/divided manner.**

Example illustrations of complaints regarding the front display and control panel

Action: In the event of a customer complaint, re-program the control unit for the PCM central computer (central display) using the PIWIS Tester.
