The Front Display and Control Panel Flickers or Fails Intermittently (221/24)

Model Line: **911 (992)**

Model Year: **As of 2024 up to 2025**

Concerns: **Front display and operator control panel**

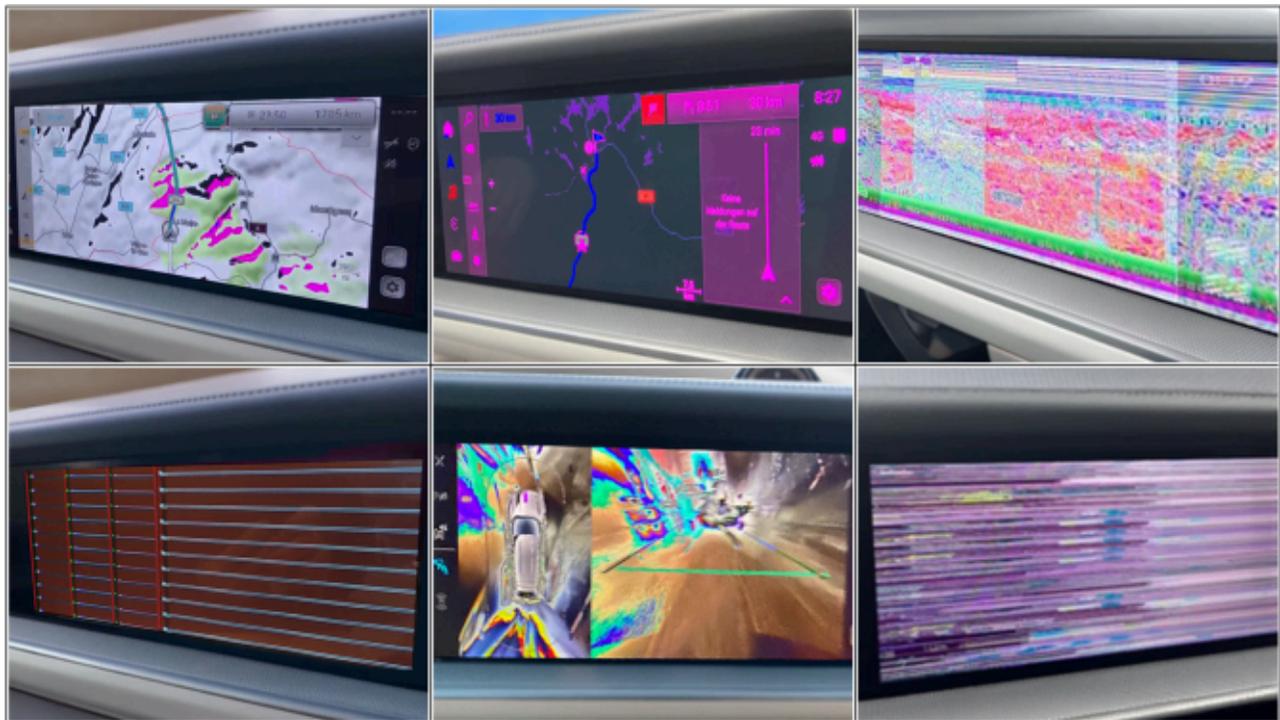
Cause: **The customer complains that the front display and control panel is flickering, fails occasionally or content is displayed in a distorted/divided manner.**

Example illustrations of complaints regarding the front display and control panel

Action: In the event of a customer complaint, re-program the control unit for the PCM central computer (central display) using the PIWIS Tester.
