**TECHNICAL INSTRUCTIONS  
FOR  
CUSTOMER SUPPORT PROGRAM 23TE08**

**COVERAGE FOR PAINT PEELING ON EXTERIOR DOOR FRAMES, FRONT INNER FENDERS  
AND A-PILLARS**

**CERTAIN 2016-2022 MODEL YEAR TACOMA**

**Updated 07.31.2025 – Add emphasis that all areas per side are to be repaired per inspection report. Update parts list.**

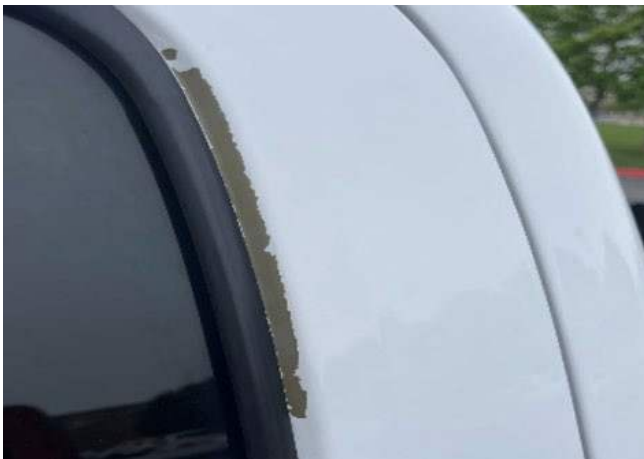
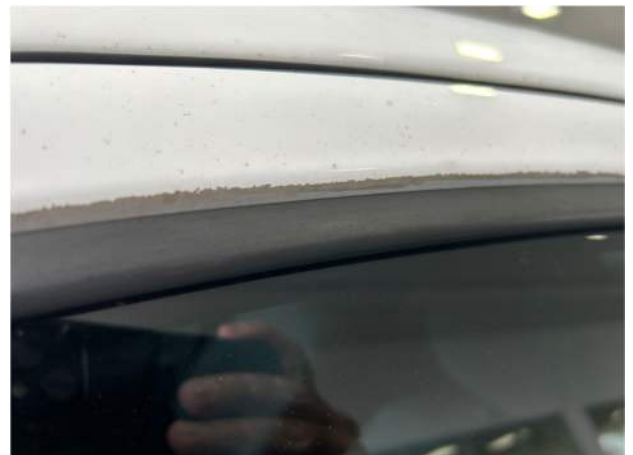
Example of peeling paint on the exterior window frame edges of the left doors

Note: If peeling is found in any of the 4 areas listed above, per side (left or right), all four areas per side will be stripped down the electro disposition layer, and repainted to ensure peeling cannot occur in the future.

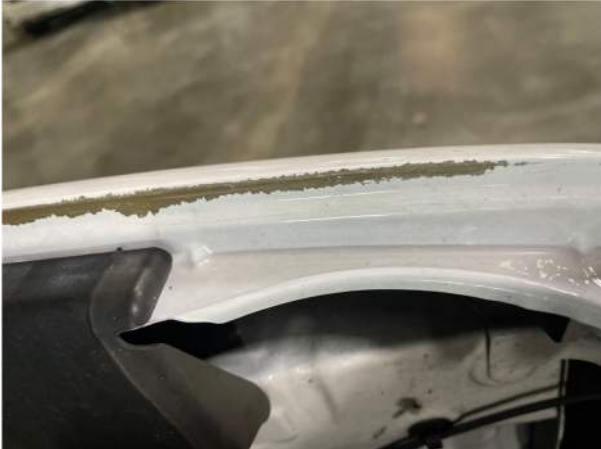
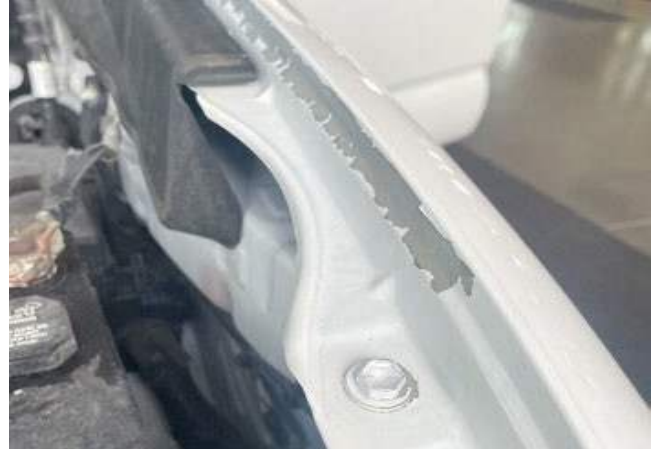
Examples of paint peeling on the front inner fender edge (can be seen with the hood open)

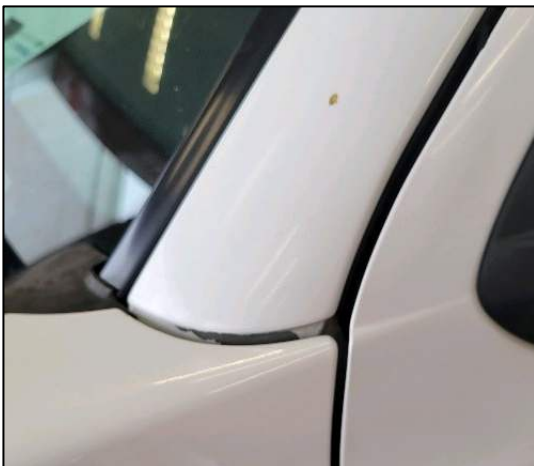
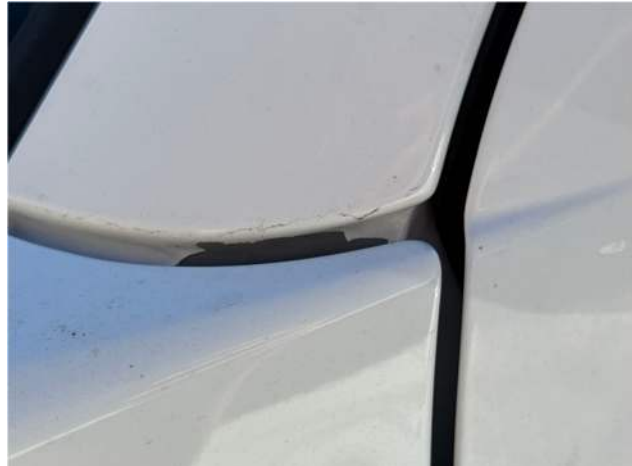
Examples of paint peeling on the left A-pillar

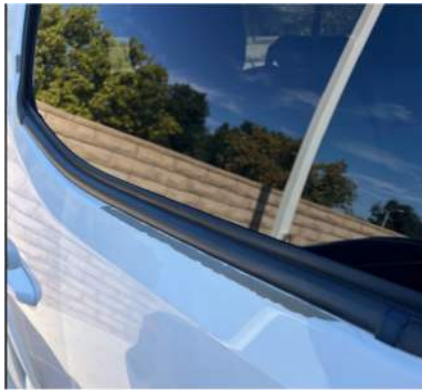
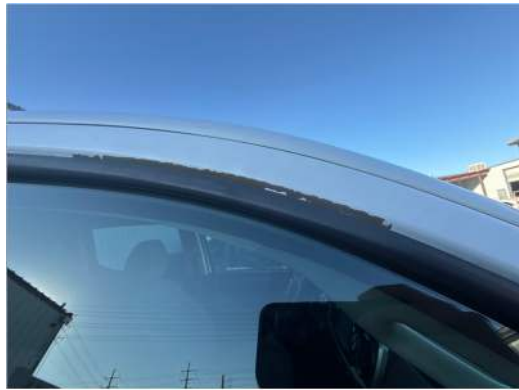
Examples of paint peeling on exterior window frame edges of the right doors

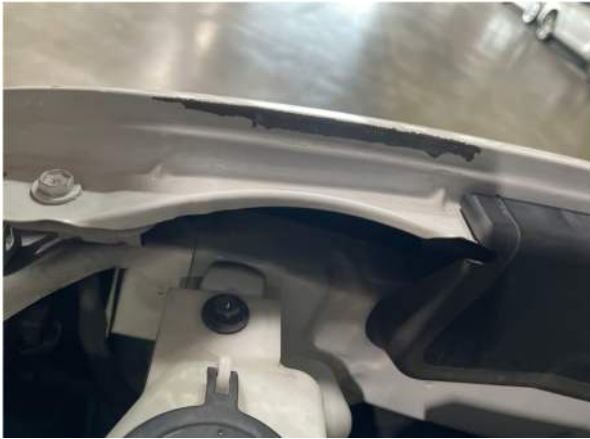
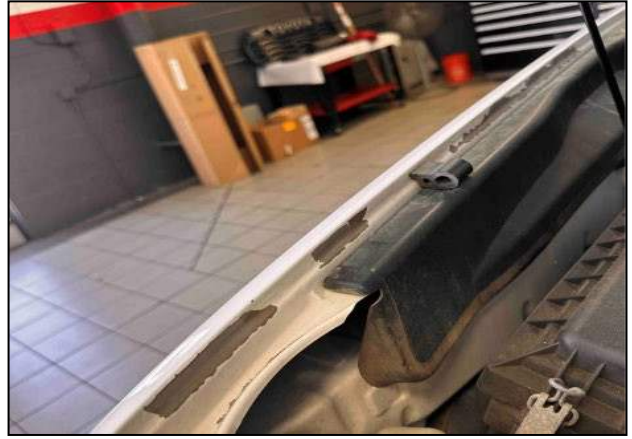
Examples of peeling paint on the right front inner fender edge (can be seen with the hood open)

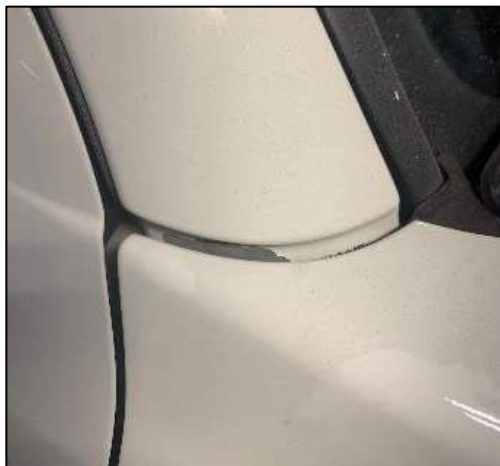
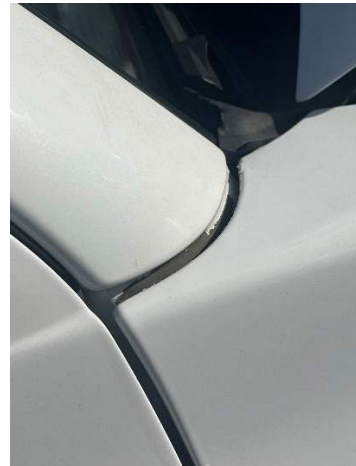
Examples of peeling paint on the right A-pillar
