WRU8 - Replacing Tailpipe Trim (Workshop Campaign)

Model Year: **2025**

Model Line: **911 (992)**

Concerns: **Tailpipe trim**

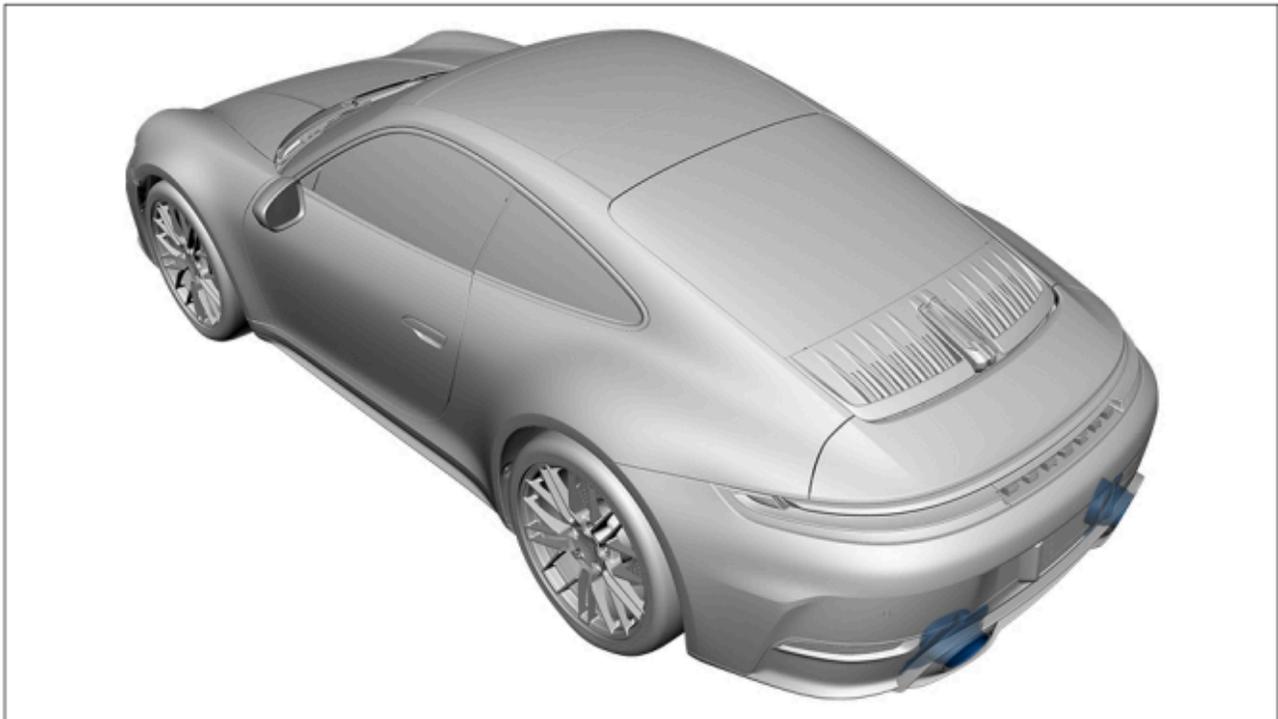
Cause: **During in-house quality analyses, it was determined that tailpipe trim that does not meet the required specifications had been installed on the affected vehicles.**
 In conjunction with high thermal loads, such as during longer high-speed driving, the air intake frame of the rear apron may become thermally deformed over its service life.
 Customers might consider this as a visual detriment.

Installation position of tailpipe trim

Action: Replace the tailpipe trim.

Work Procedure: 1 Replace previous tailpipe covers with **tailpipe trim with optimized component status**.
