**Troubleshooting: Front Window Pane Reversed – Closes and/or Opens Incorrectly (55/24)**

Model Year: **As of 2019**

Model Line: **Macan (95B)**

Concerns: **Front window pane**

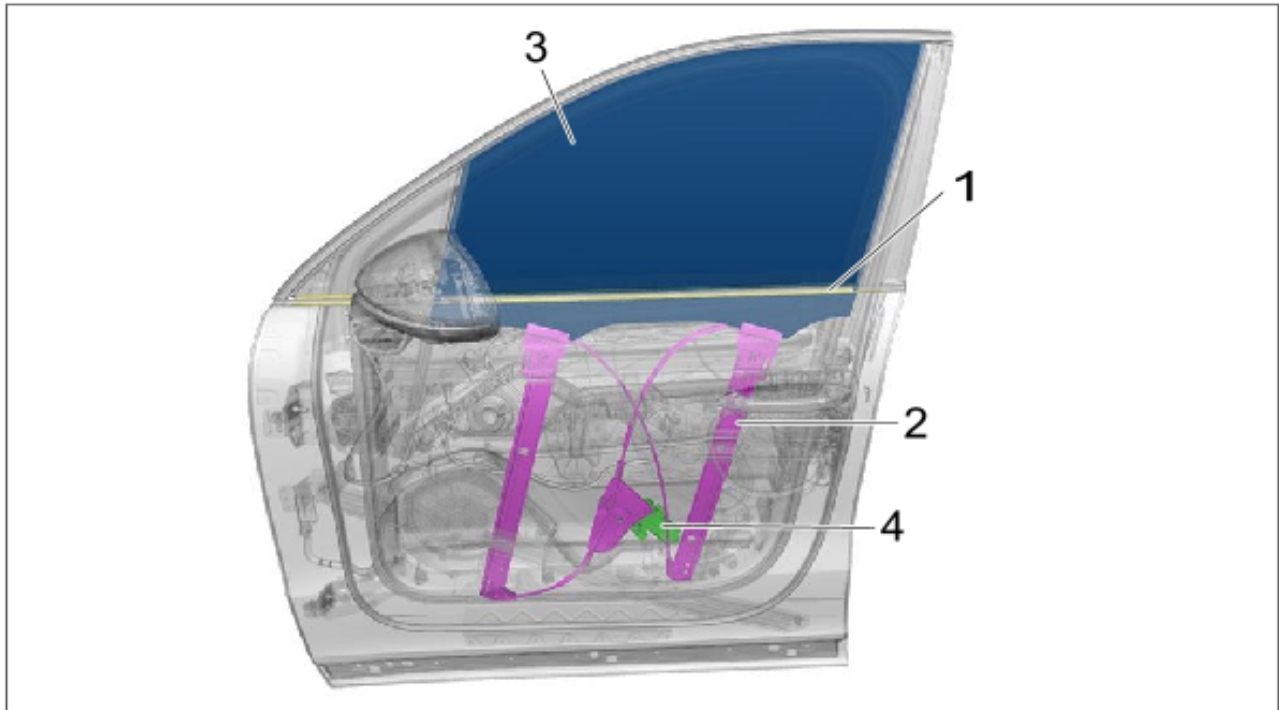
Overview of causes for front power windows malfunctions

- Deformed/damaged window shaft seal ⇒ *Overview of causes for front power windows malfunctions -1-* in the window guide
- Resistance inside the front power windows mechanism ⇒ *Overview of causes for front power windows malfunctions -2-* due to contamination or lack of lubrication
- Dirty window pane ⇒ *Overview of causes for front power windows malfunctions -3-*/high friction on the window pane ⇒ *Overview of causes for front power windows malfunctions -3-*
- Faulty power windows motor ⇒ *Overview of causes for front power windows malfunctions -4-*

- 1 – Window shaft seal
- 2 – Front power windows mechanism
- 3 – Front window pane
- 4 – Power windows motor
