HYUNDAI Technical Service Bulletin

GROUP CAMPAIGN	NUMBER 25-01-048H
DATE SEPTEMBER 2025	MODEL(S) SEE BELOW

SUBJECT: CLUSTER SPEEDOMETER SOFTWARE UPDATE
(SERVICE CAMPAIGN TDQ)

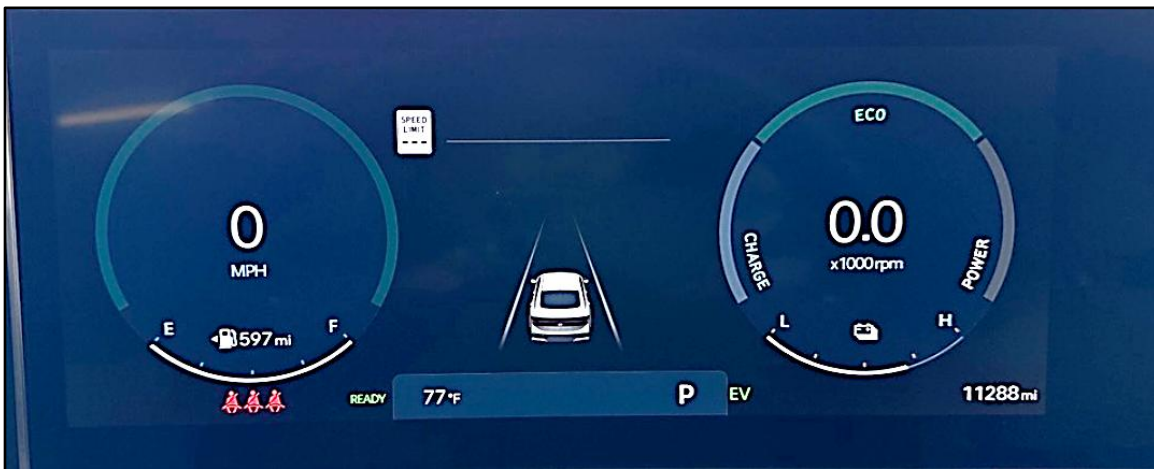
Description: Certain Sonata (DN8) and Sonata (DN8) N-Line trim vehicles equipped with the Super Vision instrument cluster (12.3” wide) may have speedometers that display the incorrect speed and/or an inoperative turbo boost gauge. This bulletin provides instructions to perform a software update to resolve this concern.
