<b>HYUNDAI</b> <b>Technical Service Bulletin</b>	GROUP <b>CAMPAIGN</b>	NUMBER <b>25-01-058H</b>
	DATE <b>SEPTEMBER 2025</b>	MODEL(S) <b>SANTA FE (MX5A) SANTA FE HYBRID (MX5A HEV)</b>
<b>SUBJECT:</b> POP, TICK, OR CREAK NOISE FROM RIGHT FRONT SUBFRAME MOUNTING STUD (SERVICE CAMPAIGN 9C4)

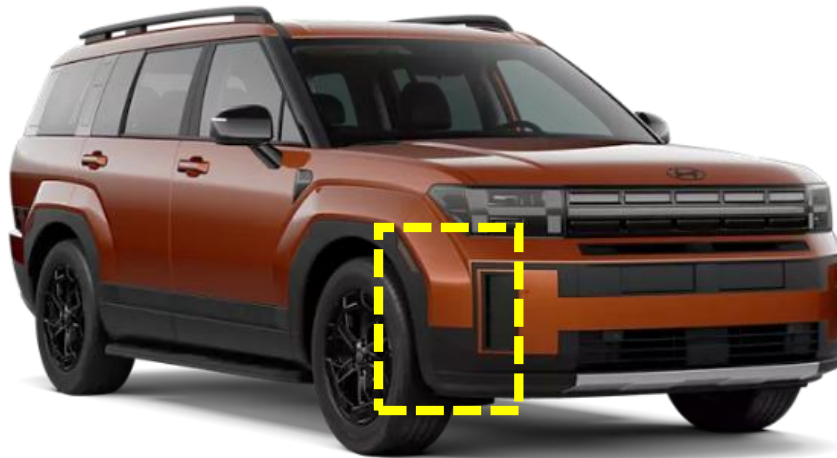
**Description:** Certain Santa Fe (MX5A) and Santa Fe Hybrid (MX5A HEV) vehicles may produce a “pop”, “tick”, or “creak” noise from a missing weld on the mounting stud of the right front subframe while driving. The vehicle’s structural integrity is maintained even with a missing weld; however, drivers may report an abnormal noise coming from the affected area during certain driving scenarios. This bulletin describes the procedure to inspect, and if necessary, repair the missing weld on the mounting stud to eliminate the noise.

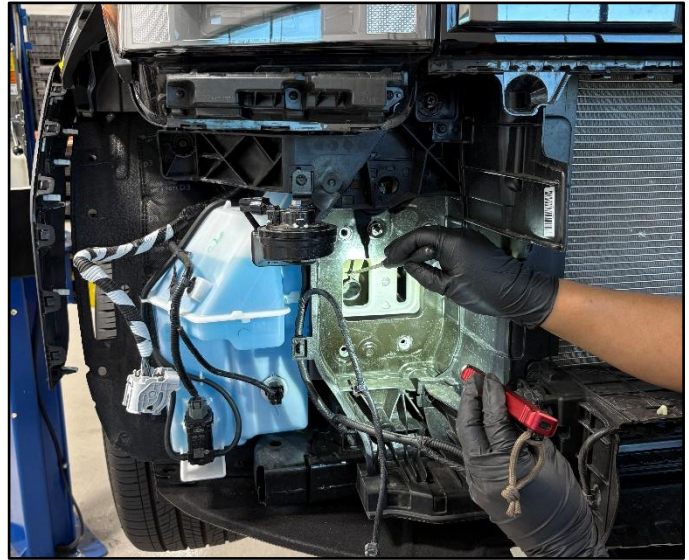
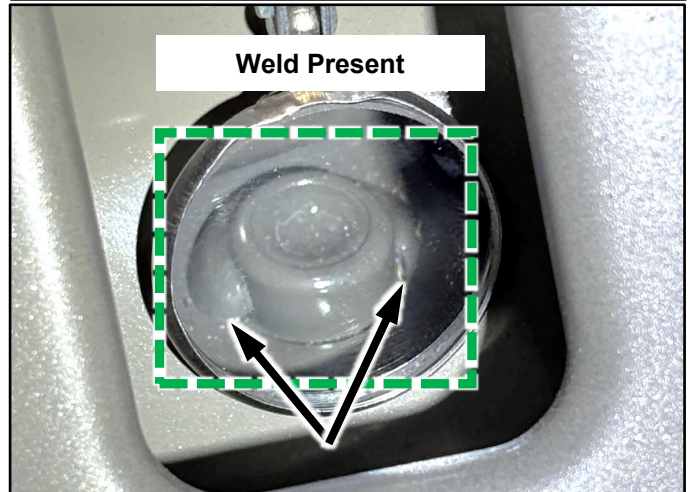
3. Using an inspection mirror, look inside the right front fender apron to locate the right front subframe mounting stud.

Inspect the condition of the weld on the right front subframe mounting stud.

- If weld is present, submit a Digital Documentation photo of the weld. Follow normal diagnostic procedures to locate and repair the source of the noise. Use operation code **50DA27R1**.

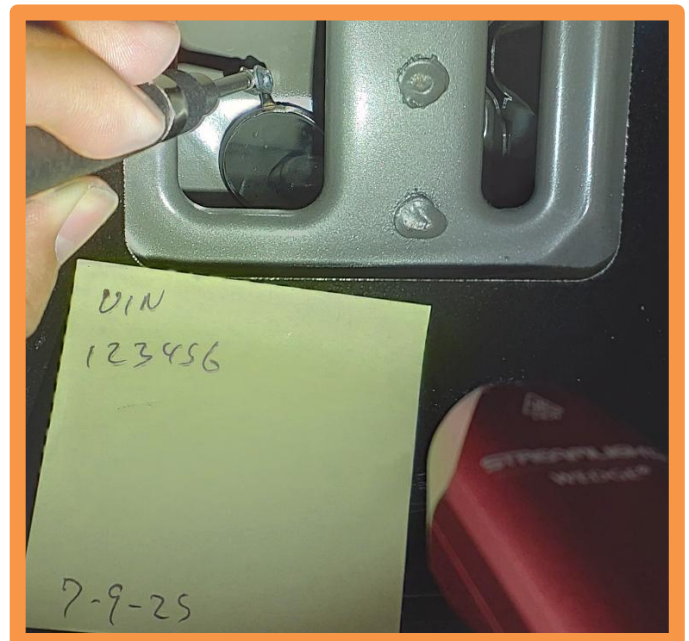
Using STUI, take a photo of the weld on the subframe mounting stud, along with the last 6 digits of the VIN and the date of repair on a piece of paper.

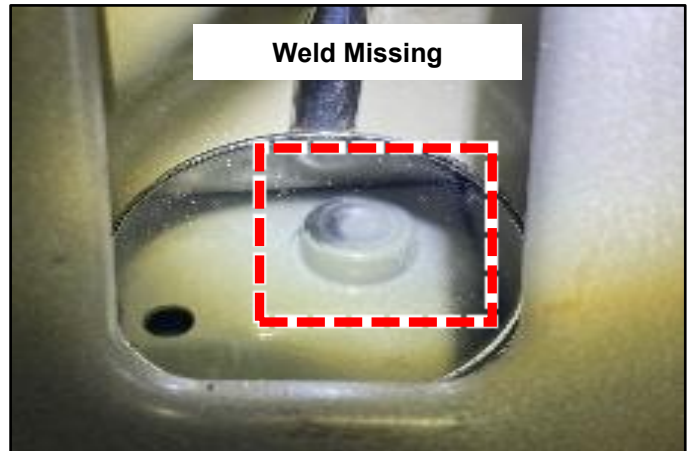
- If weld is missing, reassemble the vehicle, then sublet to a reputable body repair shop with a shielded metal arc (stick) welder.
- Provide this TSB to the body repair shop and direct their attention to the [Weld Application on Right Front Subframe Mounting Stud](#) procedure.

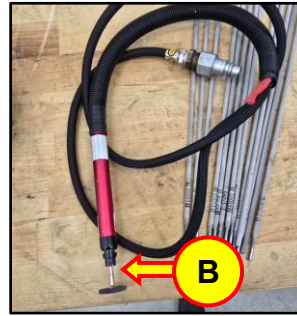
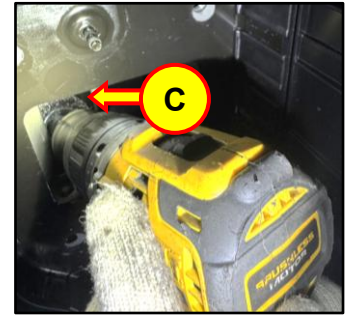
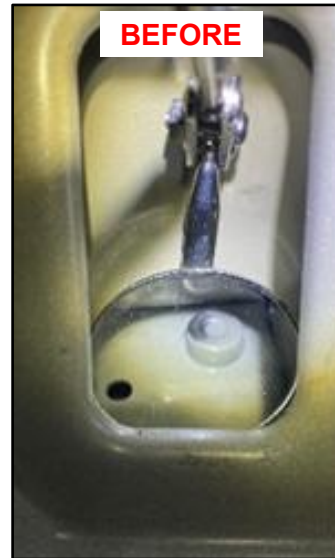
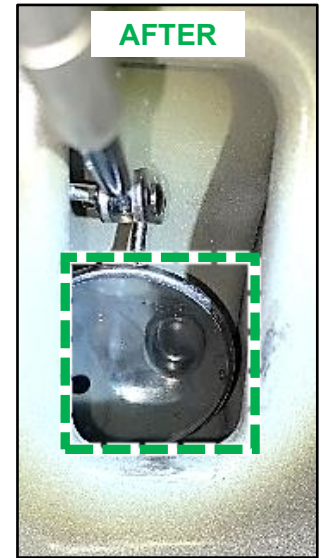
The “**AFTER**” photo on the right shows the area around the stud polished and ready to be welded.

3. Using a small pencil grinder (B) or brush attachment for an electric drill (C), polish the surface of the area to be welded to remove the e-coat.
