REFERENCE:	TSB: 03-007-25 GROUP: 03 - Differential And Driveline	Date:	September 3, 2025	REVISION:	—
VEHICLES AFFECTED:	2025 (WL) Jeep Grand Cherokee/Grand Cherokee L This bulletin applies to vehicles built on or after December 13, 2024 (MDH 1213XX) and on or before February 11, 2025 (MDH 0211XX) equipped with Conv Diff Frt Axle W/Disconnect (Sales code DSM) and 3.6L V6 24V VVT Engine Upg I w/ESS (Sales Code ERC).	MARKET APPLICABILITY:			
		<input checked="" type="checkbox"/> NA <input checked="" type="checkbox"/> MEA <input type="checkbox"/> SA <input type="checkbox"/> IAP <input type="checkbox"/> EE <input type="checkbox"/> CH NOTE: This bulletin applies to North America and Middle East & Africa markets.			
CUSTOMER SYMPTOM:	<p>Customers must experience a Malfunction Indicator Lamp (MIL) illumination and the vehicle must exhibit/set the following Diagnostic Trouble Code (DTC):</p> <ul style="list-style-type: none"> • C1463-94 - Front Axle Disconnect Control-Unexpected Operation. <p>Customers may experience one or more of the following:</p> <ul style="list-style-type: none"> • Service 4WD light is illuminated on the Instrument Panel Cluster (IPC). • Unable to shift from two-wheel

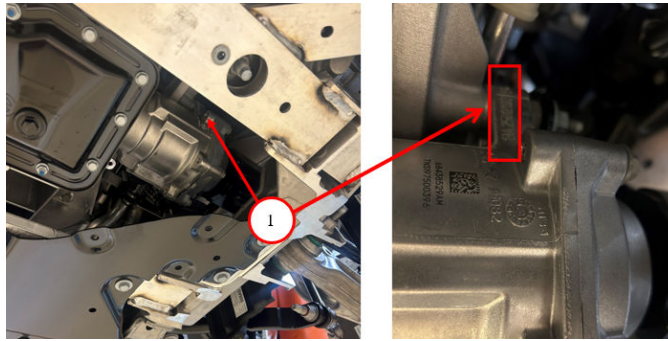
Fig. 1
FAD housing

2. Locate the stamped serial number on the FAD housing [Fig. 1](#).

1 - Serial number location

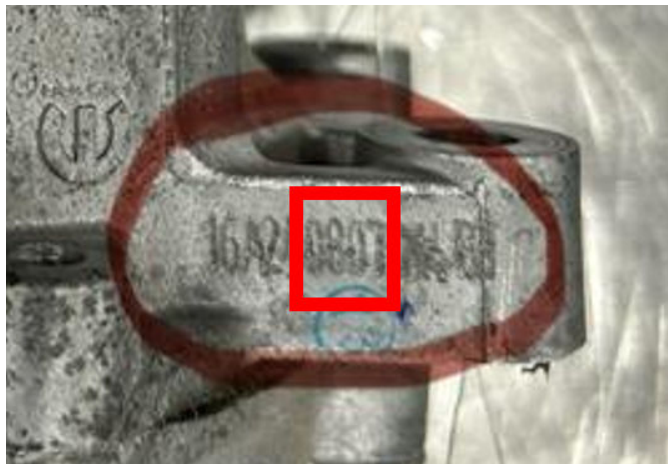
Fig. 2
Serial Number

3. Are characters 6-9 of the serial number 0807 or 0806 [Fig. 2](#)?

- YES>>> Proceed to [Step 4](#).
- NO>>> This bulletin has been completed. Use Inspection LOP (08-46-34-92) to close the active RSU and proceed to [Step 5](#).

4. Replace the FAD assembly. Refer to the detailed service procedures available in DealerCONNECT/Service Library under: Service Info> 03 - Differential and Driveline / Actuator/Motor / Removal and Installation.
5. Install the front belly pan. Refer to the detailed service procedures available in DealerCONNECT/Service Library under: Service Info> 13 - Frame and Bumpers / Under Body Protection / Belly Pan / Installation.
6. Clear DTCs.
