## STAR ONLINE PUBLICATION

**Case Number:** S2508000077

**Symptom/Vehicle Issue:** Radio Frequency Hub (RFH) Fails Flash Update Fails

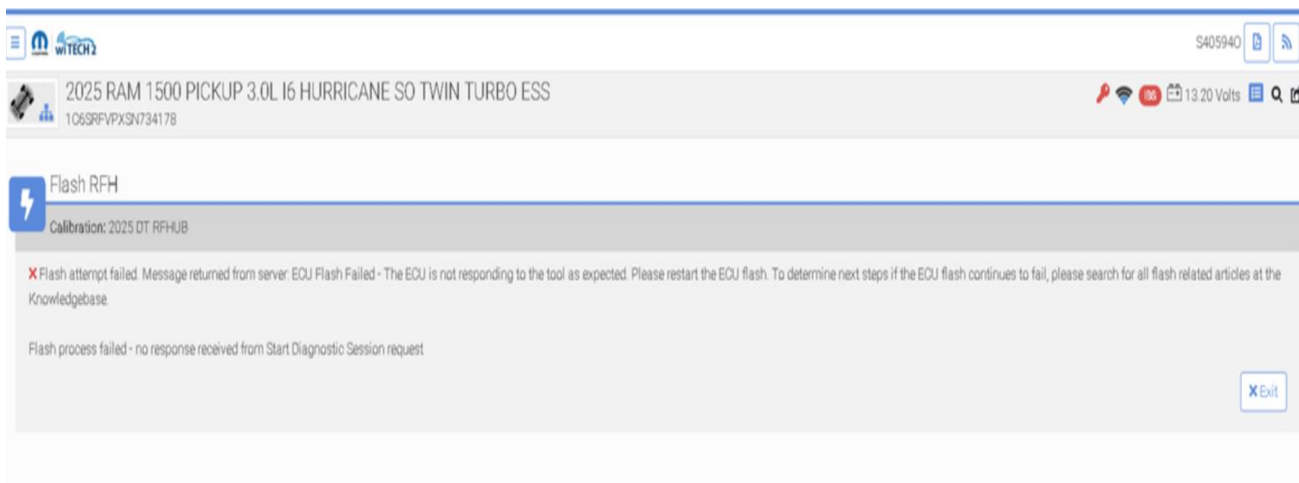
**Technician Observation:** The technician has attempted to flash the rfhub multiple times with a repeated message the flash has failed.

Example: While performing TSB 08-232-25

**Discussion:** In some cases even while maintaining the proper battery voltage the RFHUB flash fails and will not complete. In these rare cases where the RFHUB flash will may not complete, remove the B+ feed Fuse 8 for the cluster and reattempt the flash.
