STAR ONLINE PUBLICATION

Case Number: S2508000075

Symptom/Vehicle Issue: Integrated Trailer Brake (ITB) Switch Removal

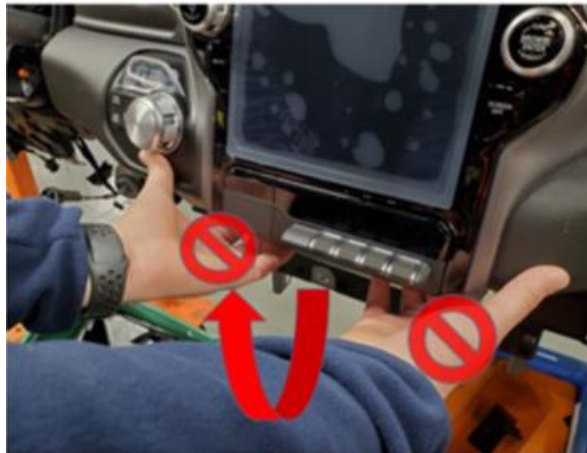
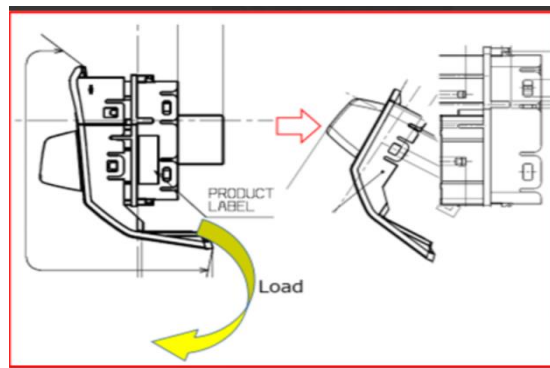
Technician Observation: Technician is looking to remove or replace the ITB switch from the Instrument Center Stack (ICS) switch cover.

Repair Procedure: To avoid damage to the ITBM switch see below method of removal.

Pull down and straight out with limited upward force.
