GROUP	MODEL
	ELE	2023-2024MY Sportage (NQ5 HEV)
	NUMBER	DATE
	399	September 2025

TECHNICAL SERVICE BULLETIN

BMS DISCHARGE LOGIC IMPROVEMENT

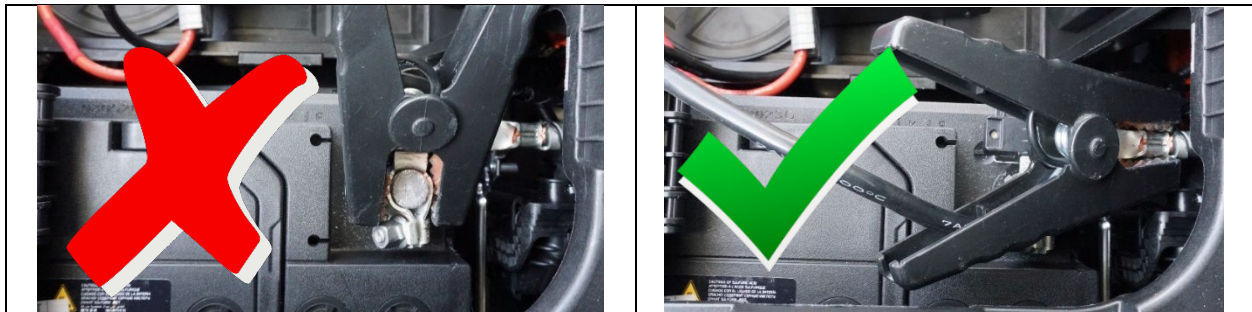
[Connect the negative \(-\) terminal to the battery as shown below.](#)
