GROUP	MODEL
BOD	2025MY EV9 (MVa)
NUMBER	DATE
343	September 2025

## TECHNICAL SERVICE BULLETIN

### SERVICE ACTION: OUTSIDE DOOR HANDLE COVER SCREW REPLACEMENT (SA627)

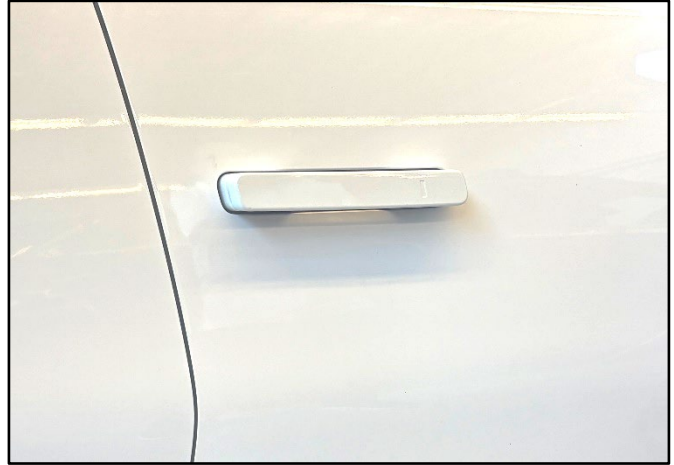
1. Ensure all four (4) door handles are fully retracted (the doors should be in the deployment position).

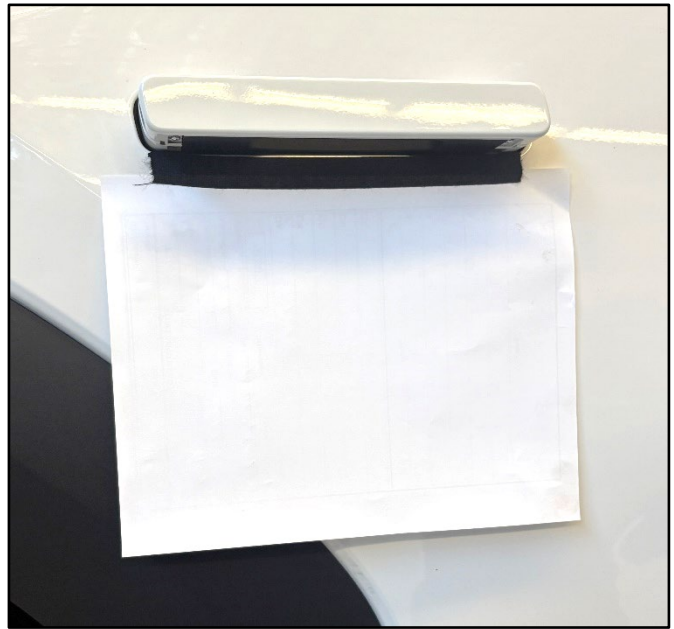
If needed, adhere a piece of paper to the doors just below the door handle to add protection while working.

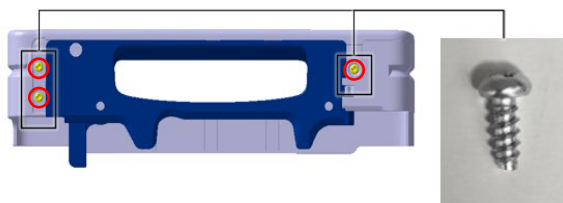
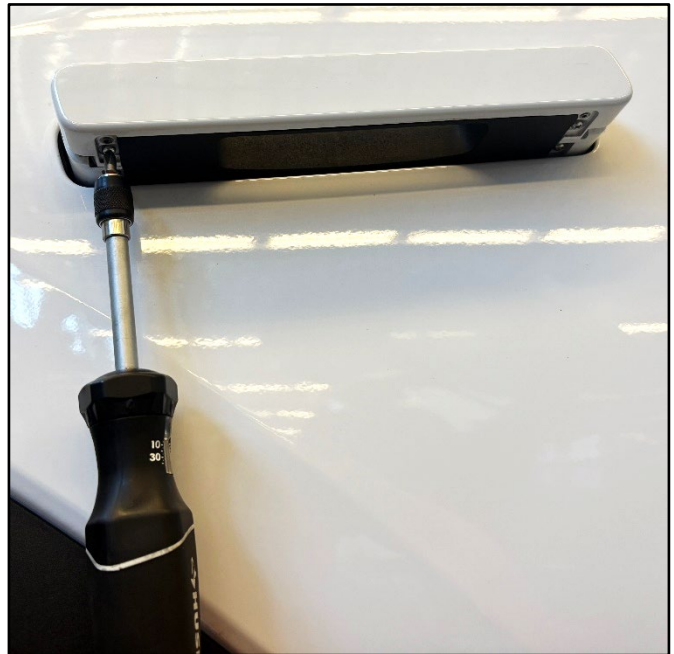
The left front driver outside door handle has three (3) screws as shown below.

Using a #1 phillips screwdriver, remove the four (4) door handle retaining screws.
