GROUP	MODEL
TRA	2022-2024MY Sorento Plug-In Hybrid (MQ4 PHEV) with 1.6L T-GDI AWD
NUMBER	DATE
112	September 2025

TECHNICAL SERVICE BULLETIN

TRANSAXLE ASSEMBLY REPLACEMENT & HCU LOGIC IMPROVEMENT

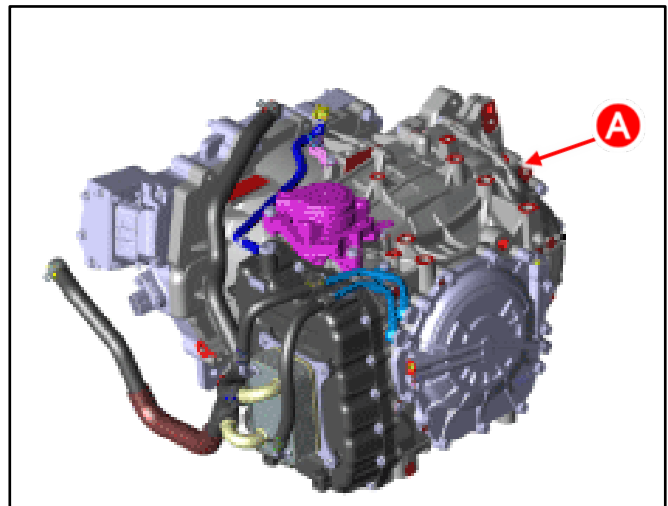
This bulletin provides information to replace the transaxle assembly and upgrade the Hybrid Control Unit Low-Voltage DC Converter (HCULDC) software on some 2022-2024MY Sorento Plug-In Hybrid (MQ4 PHEV) vehicles equipped with a 1.6L T-GDI engine and All-Wheel Drive (AWD), produced from June 29, 2021 through January 10, 2024. Some vehicles may experience an illuminated Malfunction Indicator Lamp (MIL) with DTC POC4E00 stored, accompanied by a rough transition when the vehicle switches between EV and HEV motive power. Follow the procedure outlined in this publication to replace the transaxle assembly and upgrade the HCULDC system software for the applicable vehicle exhibiting an MIL 'ON' with DTC POC4E00 stored.

POC4E00 - Drive Motor "A" Position Exceeded Learning Limit

2. Replace the Automatic Transaxle Assembly (A) by referring to "Automatic Transaxle System → Automatic Transaxle System → Repair procedures" in the applicable Shop Manual on KGIS.
