GROUP	MODEL
BOD	2019-2020MY Optima (JFa)
NUMBER	DATE
324 (Rev 1, 09/05/2025)	March 2024

TECHNICAL SERVICE BULLETIN

SIDE AIRBAG (SAB) INSPECTION AND REPLACEMENT FOR DTC(S) B1380/B1384

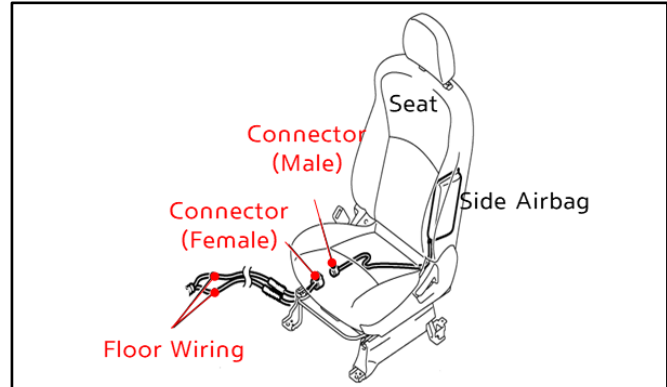
1. Confirm 'Airbag' warning indicator lamp is 'ON' and using KDS, scan for DTC(s):

- **B1380** - Side Airbag Front Driver Resistance Circuit Short to Ground
- **B1384** - Side Airbag Front Passenger Resistance Circuit Short to Ground.

- 2a. If the 'related' DTC is not present (other airbag concern) then this TSB is not applicable. 'Inspection Only' claim.
- 2b. If the 'related' DTC is stored (Driver or Passenger, or both) proceed to step 3. A Vehicle Diagnosis Number (VDN) must be created for DTC's B1380 and or B1384.
