Technical Service Bulletin

GROUP CAMPAIGN	NUMBER 25-01-059H
DATE SEPTEMBER 2025	MODEL(S) TUCSON (NX4)

SUBJECT: DCU SOFTWARE UPDATE
(SERVICE CAMPAIGN TDFA)

Description: Certain Tucson (NX4) vehicles may exhibit a Data Communication Unit (DCU) software error due to the internal timer initialization logic not being implemented. The DCU module may shut down telematics services after one year. This bulletin provides instructions to perform a software update for the DCU module.

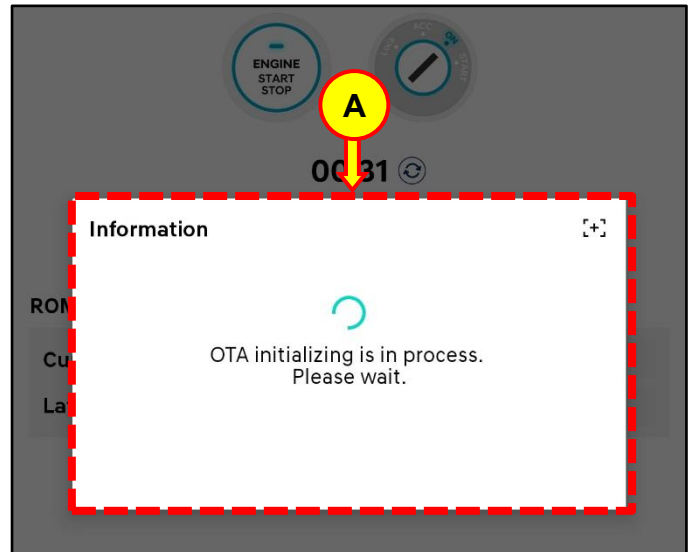
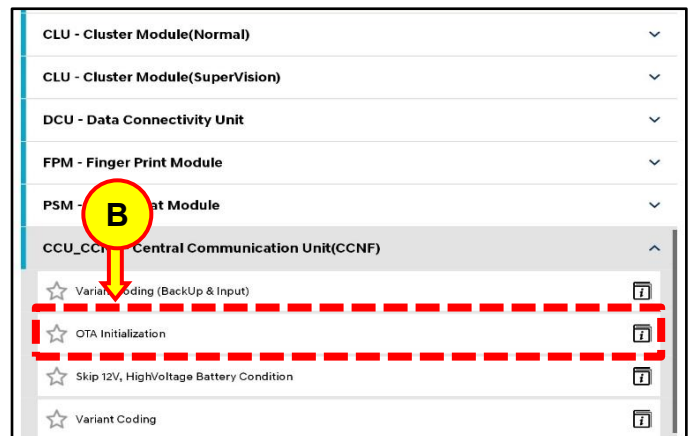
- OTA initialization (A) should perform automatically:
 - If OTA initialization performs automatically, then proceed with the service procedure.
 - If the OTA initialization process fails, complete it manually under: **S/W Management > CCU_CCNF - Central Communication Unit (CCNF) > OTA Initialization (B)**.
