<b>HYUNDAI</b> <b>Technical Service Bulletin</b>	GROUP <b>BODY ELECTRICAL</b>	NUMBER <b>25-BE-018H</b>
	DATE <b>SEPTEMBER 2025</b>	MODEL(S) <b>VENUE (QX)</b>
<b>SUBJECT:</b> INOPERATIVE HORN ASSEMBLY REPLACEMENT (WARRANTY EXTENSION TXXU)

**This TSB supersedes 24-BE-018H to revise the Applicable Vehicles, Parts Information, Warranty Information, and Service Procedure sections.**

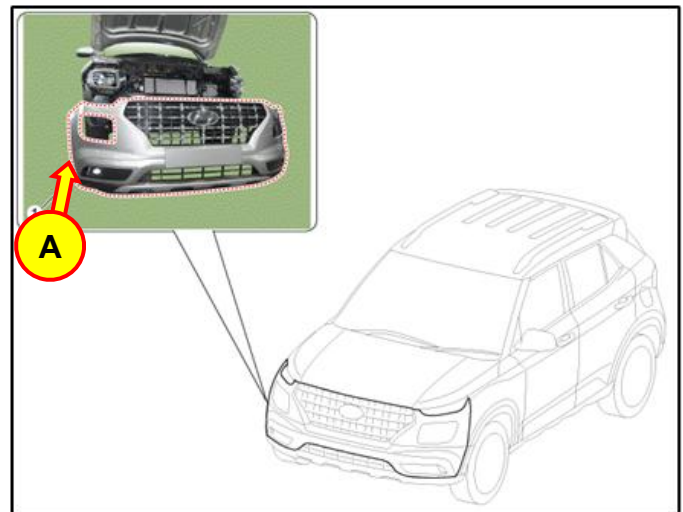
3. Refer to the shop manual to remove the front bumper assembly (A):
  - **Body (Interior and Exterior) > Front Bumper > Front Bumper Cover > Repair procedures**

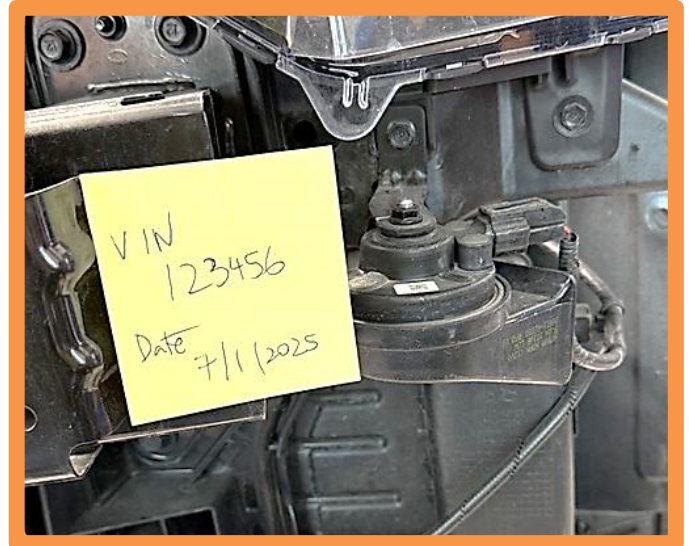
Using STUI, take a photo of the original horizontally mounted horn with the last 6 digits of the VIN and the date of repair on a piece of paper.
