SIB 64 05 25

HVAC FLAP LINKAGE NOT FULLY CONNECTED

E-Series	Model Description		
G45	X3 Sports Activity Vehicle

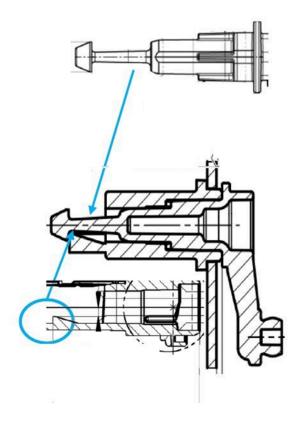
This can occur to ANY of the flaps in the HVAC system. See attached video for one example BV64 02 25 G45 Flap Linkage

There is a push-in end on the linkage that can be reinserted into the flap and fully seated.

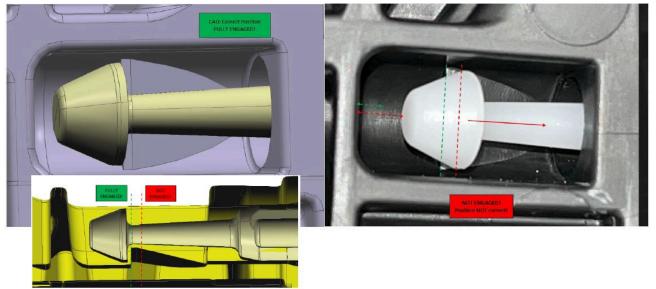
To test if the mechanism is fully seated into the HVAC flap assembly, perform a wiggle test of the white plastic (in/out). Here you can see the white plastic mechanism has backed out of the HVAC case and is not locked into the flap.

until it fully goes past the plastic flap ramp. The pictures below show fully locked in vs not fully locked.

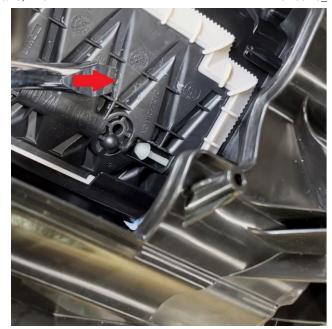
There is a push-in end on the linkage that can be reinserted into the HVAC flap and fully seated. The white plastic mechanism push pin can be reinserted into the HVAC flap and fully seated.

Make sure to push in until you can feel the white plastic mechanism push pin mushroom-shaped end engage into the flap ramp.

NOTE: The linkage may bottom against the HVAC case before it fully seats into the flap. This is because the flap may have some side-to-side free play. In this case apply OUTWARD pressure* on the flap while pressing INWARD on the linkage until it fully engages. This may require more disassembly of the ducts to access the flap. The fresh air blend uses two linked flaps, and you may have to go around the top flap to put pressure on the lower flap.

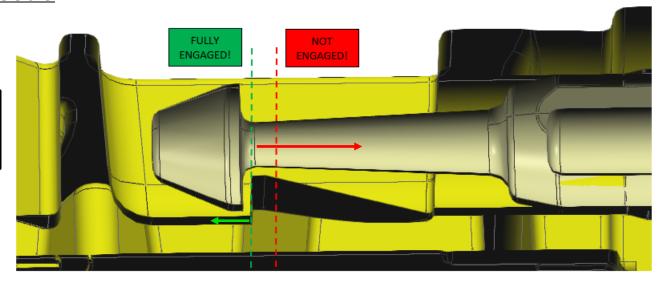
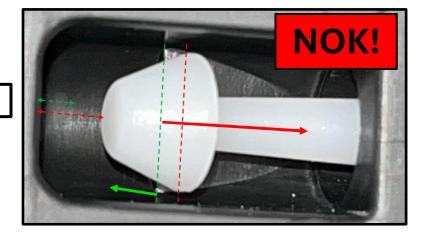
Push Pin Issue

--- FULLY Engaged ----- NOT FULLY Engaged ---

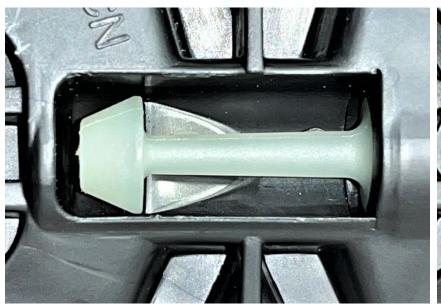
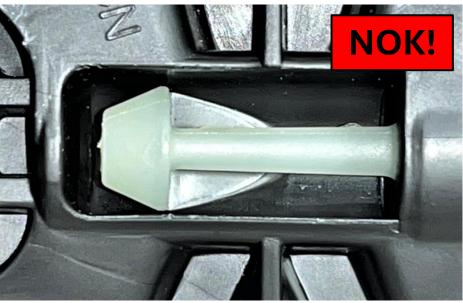
Push Pin Issue

FULLY ENGAGED

Pin/Linkage Mushroom Head Completely Over Ramp on Flap!

NOK!

Barely short of FULL engagement!

Pin/Linkage Mushroom Head NOT Completely Over Ramp on Flap!

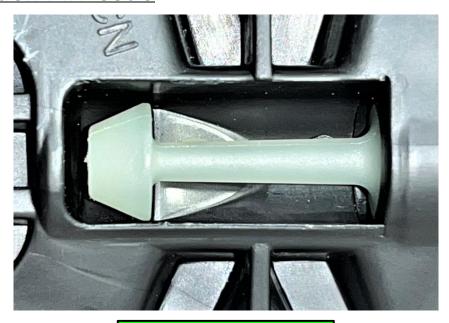
Push Pin Issue

FULLY ENGAGED

Pin/Linkage Mushroom Head Completely Over Ramp on Flap!

Short of FULL engagement!

Pin/Linkage Mushroom Head NOT Completely Over Ramp on Flap!

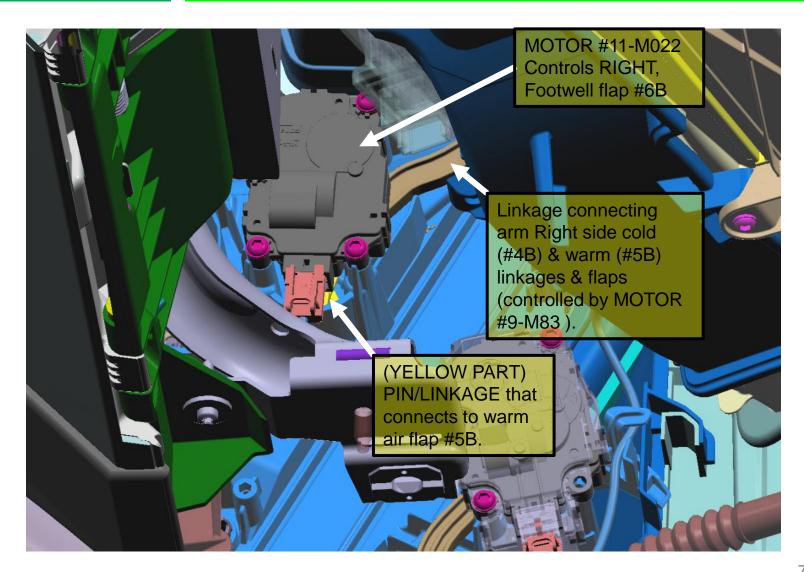
Reference Picture: E- VIEW after under-dash and footwell duct removed

- Confirm NOK Condition (loose linkage to flap)- Minor Disassembly!
- **B)** Locate and wiggle the linkage connecting arm between the cold and warm mixing flaps and look for excessive looseness at the lower end of the linkage connecting arm and directly at the warm mixing flap pin/linkage (connection to the warm mixing flap). A boroscope could also be helpful.

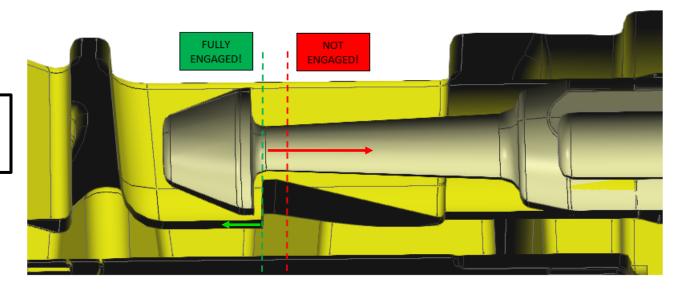
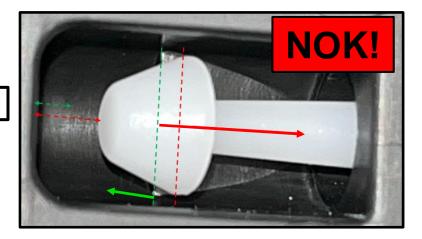
Reference Picture: A- Fully Engaged vs NOT Fully Engaged

--- FULLY Engaged ----- NOT FULLY Engaged ---

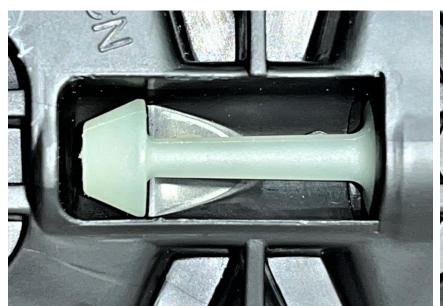
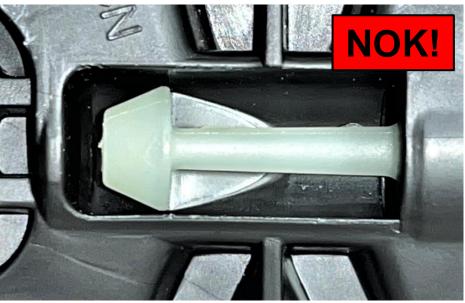
Reference Picture: B- Fully Engaged vs NOT Fully Engaged

FULLY ENGAGED

Pin/Linkage Mushroom Head Completely Over Ramp on Flap!

NOK!

Barely short of FULL engagement!

Pin/Linkage Mushroom Head NOT Completely Over Ramp on Flap!

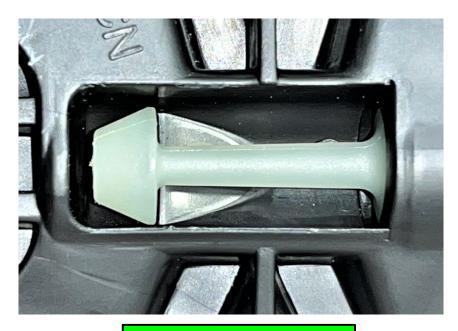
Reference Picture: C- Fully Engaged vs NOT Fully Engaged

FULLY ENGAGED

Pin/Linkage Mushroom Head Completely Over Ramp on Flap!

Short of FULL engagement!

Pin/Linkage Mushroom Head NOT Completely Over Ramp on Flap!
