SIB 64 10 25

MALFUNCTION OF CLIMATE TEMPERATURE DISPLAY AFTER SW  
UPDATE TO 25-07-500+

2025-09-09

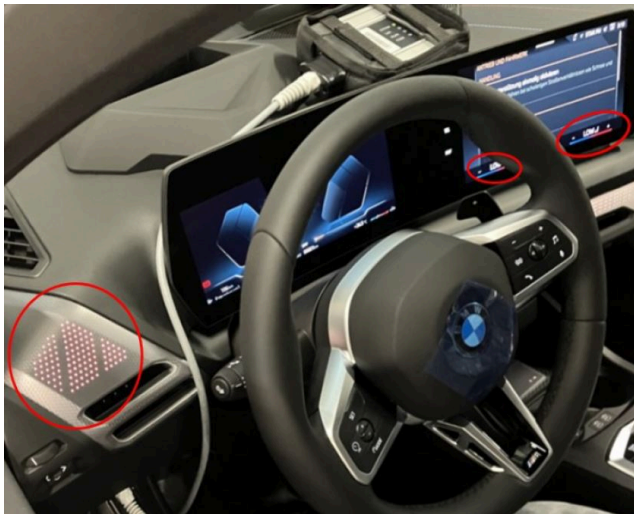
After programming the vehicle via ISTA/RSU to 25-07-5xx, the temperature display at the bottom of the Central Information Display (CID) may display the incorrect color for the temperature setting (i.e., the color shows red when the air conditioning is active (circled), instead of the intended blue).

Unfavorable logic in the LED control unit hub.

Follow the test plan to encode the LED control unit hub.

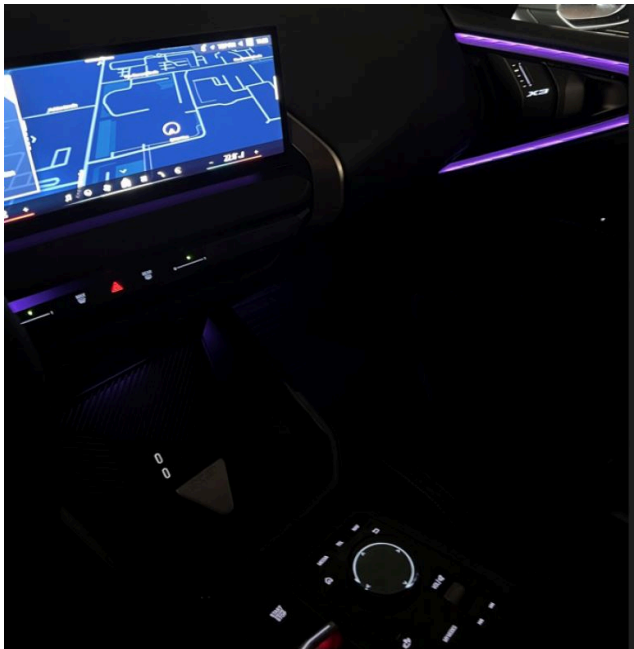
Also, some of the ambient lighting strips may no longer function properly.
