SIB 63 09 25 FAILURE/MALFUNCTION OF THE AMBIENT LIGHTING

2025-09-09

E-Series	Model Description	Affected Option Code
F74	2 Series Gran Coupe	43U – Illuminated Aluminum Graphite Trim, or
		43Z – M Illuminated Aluminum Hexacube Matte Trim
G45	X3 Sports Activity Vehicle	4UR – Ambient Lighting

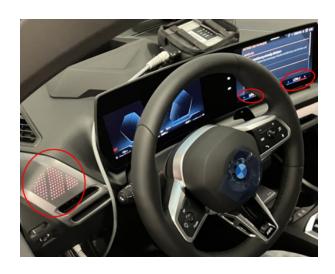
After programming the vehicle via ISTA/RSU to 25-07-5xx, some of the interior ambient lighting strips (examples circled) may no longer function properly.

- 804A38 Interior lights layering (IL-LIN_3): versioning incorrect: LIN slave 5
- 804A39 Interior lights layering (IL-LIN_3): versioning incorrect: LIN slave 6
- 804A3E Interior lights layering (IL-LIN_3): versioning incorrect: LIN slave 11

Unfavorable logic in the LED control unit hub.

Follow the test plan to encode the LED control unit hub.

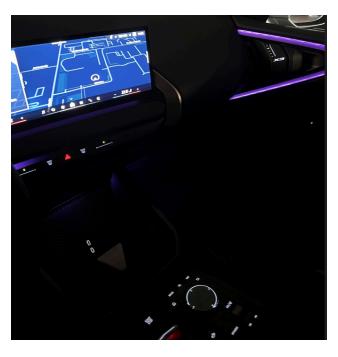
- 804A34 Interior lights layering (IL-LIN_3): versioning incorrect: LIN slave 1
- 804A35 Interior lights layering (IL-LIN_3): versioning incorrect: LIN slave 2
- 804A36 Interior lights layering (IL-LIN_3): versioning incorrect: LIN slave 3
- 804A37 Interior lights layering (IL-LIN_3): versioning incorrect: LIN slave 4
- 804A38 Interior lights layering (IL-LIN_3): versioning incorrect: LIN slave 5
- 804A3A Interior lights layering (IL-LIN_3): versioning incorrect: LIN slave 7
- 804A47 Interior lights layering (IL-LIN_3): versioning incorrect: LIN slave 8

804A48 - Interior lights layering (IL-LIN_3): versioning incorrect: LIN slave 9
