Maserati

Grecale Front Camera Bracket Inspection and Repair

DATE: September 8, 2025

MODELS: M182 Grecale (All MY).

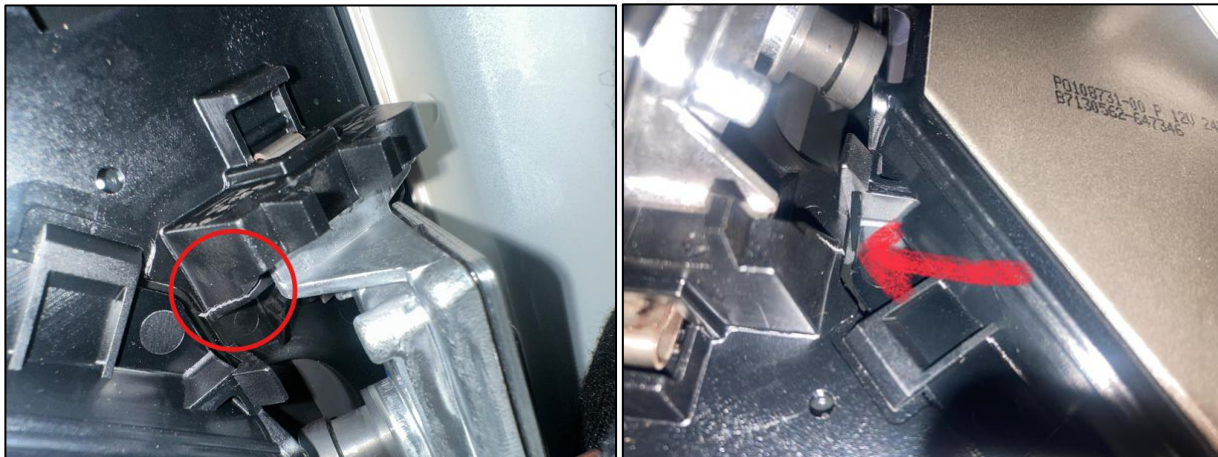
1. Inspect the **front camera bracket** on the inside of the windshield.
 - If damaged (see reference photos and videos provided):
 - Replace the windshield.
 - If no damage is found:
 - Continue with full diagnostic procedures per **Blue On Line (BOL)** policies.
