MAS004871 RU 25-25

Rapid Update 801

Grecale – Front Seats Lumbar Support Check

DATE: September 8, 2025

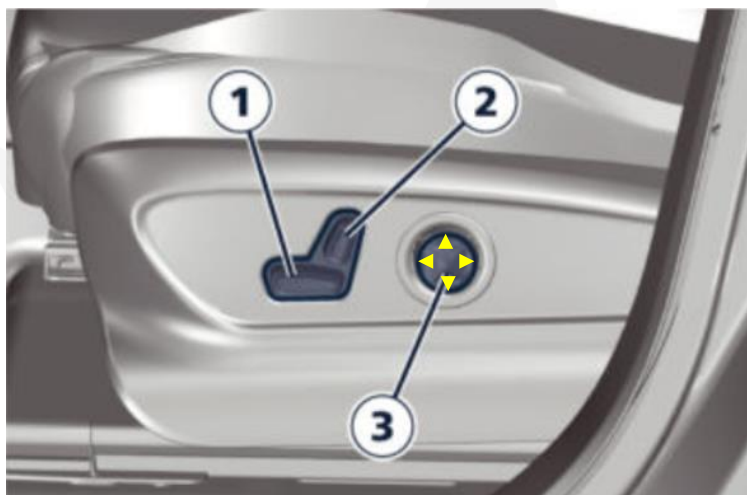
Some vehicles may have a lumbar support that, in rare cases, does not fully deflate after inflation.

1. Always check ModisCS+ to see if the vehicle is involved in this action and if it has not been previously performed.
2. Apply interior protections
 - Op. Code 00.AA.005 – Vehicle Interior Protection.
3. Operate lumbar controls
 - Use the seat-mounted switch (see figure below #3).
 - Horizontal arrows → increase/decrease lumbar inflation.
 - Vertical arrows → raise/lower lumbar position.

4. Perform a diagnostic test.
 - Complete 5 full inflation/deflation cycles on both driver and passenger seats.
 - After each cycle, confirm the lumbar support returns to the rest position.
5. Evaluate results
 - Compliant (OK): Lumbar support inflates/deflates correctly in all cycles → no further action required.
 - Non-Compliant (KO): If the support remains inflated or fails to return to position → replacement is required.
6. If replacement is necessary
 - Replace the lumbar support per Workshop Manual procedure:
 - 9.41.155 – Lumbar Support Removal, Reattachment, or Replacement.
 - Reinstall all disassembled components.
7. Finalize
 - Confirm correct function after reassembly.
 - Approve and release the vehicle.
