## HV DC/DC converter N83/1 HV voltage divider, reduction in resistance leads to BUCK mode fluctuations and ESP warning message

| Topic number | LI42.45-P-079407 |
| Function group | 42.45 - Electronic stability program (ESP) |
| Validity | 243 EQB |

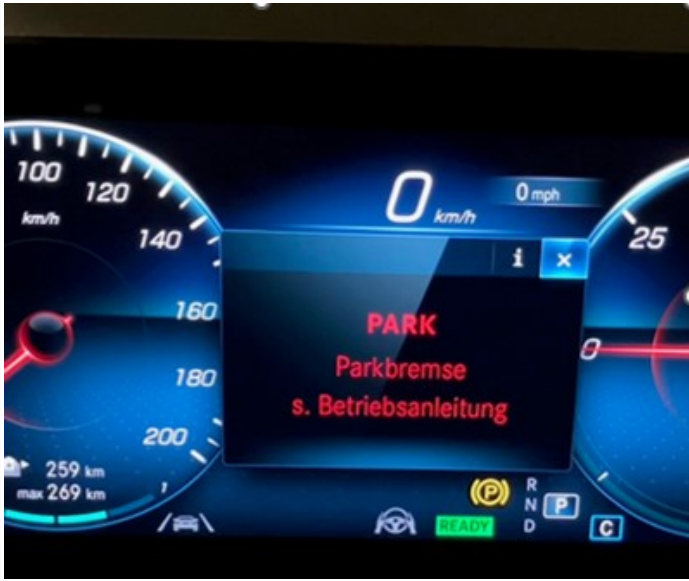
Instrument cluster warning lamp and/or warning message for brake system, EPB, ESP (yellow or red) and possibly 12 V battery (red)

| Attachments | |
|---|---|
| DCDC KAMAYA Parkbremse Meldung KI DE.jpg | Warning message EPB, German |

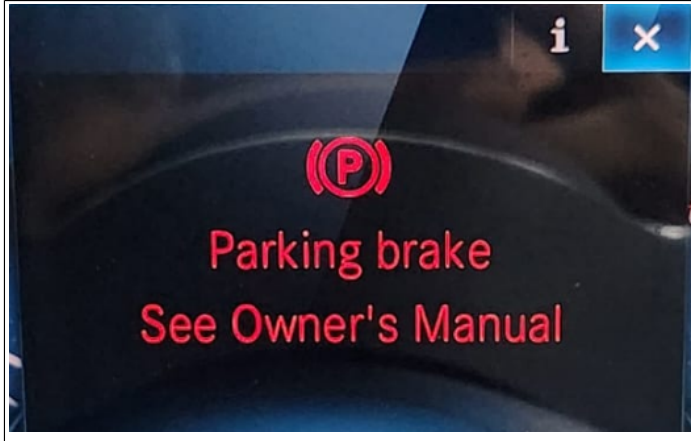
| Attachments | |
|---|---|
| DCDC KAMAYA Parkbremse Warnmeldung rot englisch.png | Warning message EPB, English |

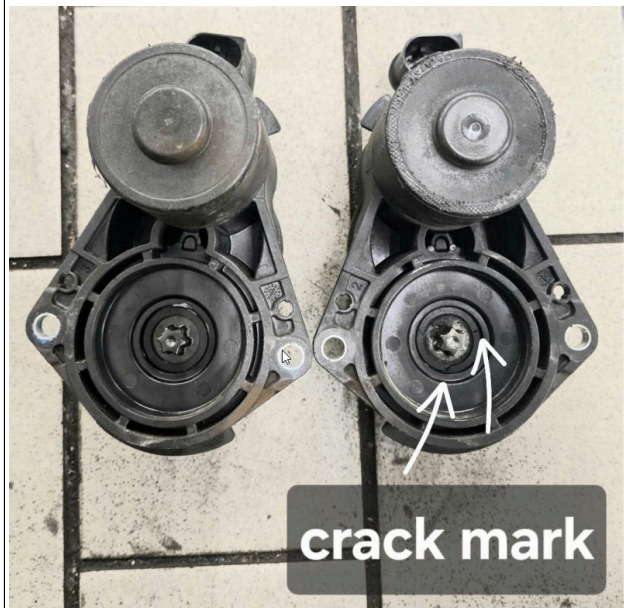
[EPB Aktuator Sicherungsring gebrochen.jpg](#)

Actuator, retaining ring (possible malfunction)

- Check of the actuators and brake caliper piston
- Manually extend and retract the piston on the brake caliper completely using the suitable socket
- If the piston sticks at a certain point, the rotation force increases significantly
- If the brake caliper piston sticks, the brake caliper has to be replaced
- If the retaining ring of the actuator is broken, the actuator has to be replaced
- In XENTRY, edit the stored test instructions of the remaining DTCs
