Service Bulletin

Bulletin No.: PIT6053C

Subject:

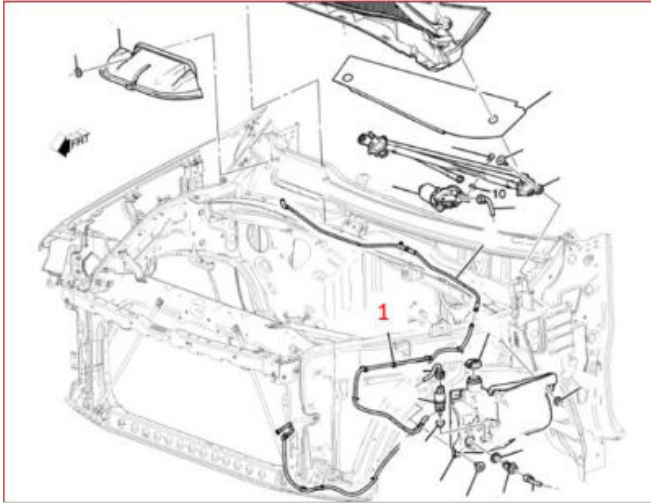
6444856

Involved Region or Country	North America
Additional Options (RPO)	UV2
Condition	Some customers may comment that the Frontview Camera Washer Nozzle is leaking washer fluid.
Cause	Some drizzle / dribble from the front grille camera nozzle after using the windshield washers is normal. If a steady stream of washer fluid is leaking from the front grille camera nozzle there could be an issue with the check valve built into the windshield washer hose that connects to the washer pump.

If no other root cause is found, then the check valve is included with the windshield washer hose that connects to the washer pump (#1 below) and replace as necessary.
