# Thor Motor Coach Technical Service Bulletin

TSB #	TSB 25-04		
Description/Title:	TriMark Door Lock		
Affected Product Line(s):	Certain model year 2025-26 Aria & Riviera		
Service Campaign # :	RC000330		
Codes:	<b>Inspect with Repair:</b> TMCTS10120W	Document Date:	9/16/2025
Time Allowed:	<b>Inspect with Repair:</b> 0.33	Document Revision:	A

# Technical Service Bulletin

TriMark Corporation 030-0900 Motor Home Entrance Door Hardware

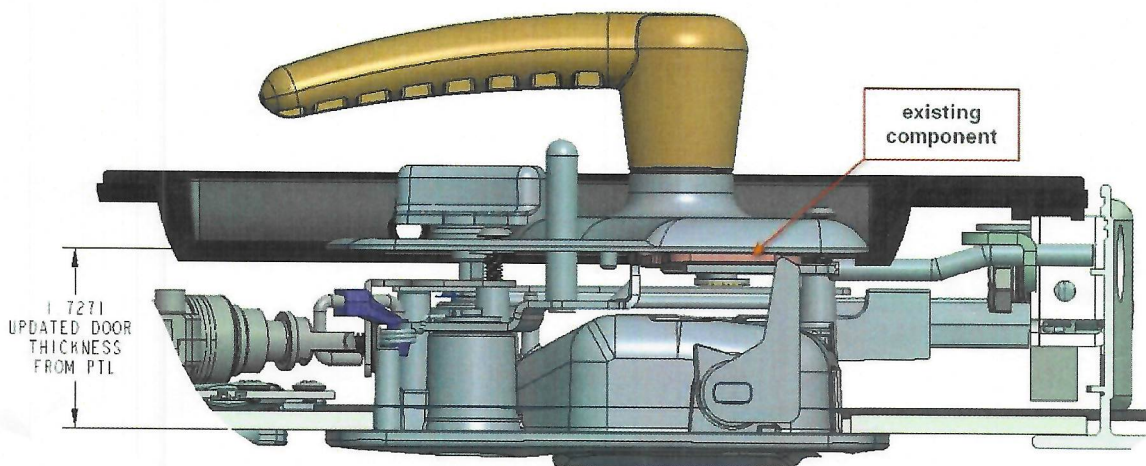
21396-05 / 36285-02 IN 1.7271" PTL DOOR

TriMark manufactured and sold to PTL, a complete RV door hardware system. PTL Engineering has reported that several Motor Coach Manufacturers have encountered issues with motorhome lockouts affecting coach owners on sold units. It was found that the pivot arm on the outside handle may pass underneath the release arm of the inside handle, due to multiple potential root causes preventing the door from opening from the outside handle. However, the interior handle is still operational from inside of the motor home.

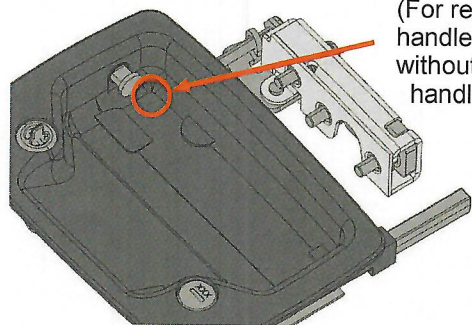
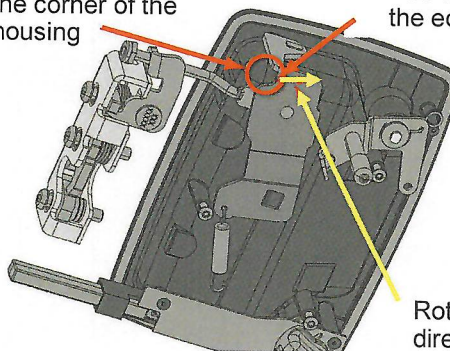
Drill hole close to the corner of the housing

You need to get access to the edge of this pivot plate

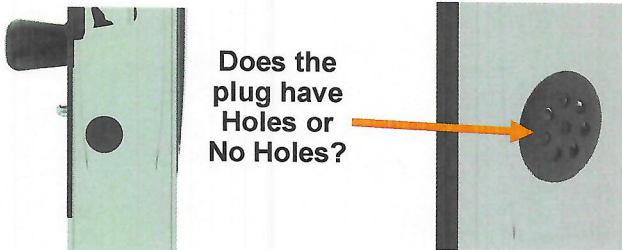
**Step 1:** Inspect the Black Plastic Plug on the door edge to see if there are holes on the top. If there are, the door hardware has already been upgraded, please disregard these TSB instructions.

Does the plug have Holes or No Holes?

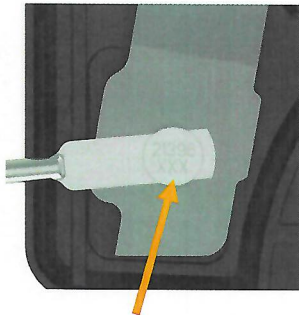
**Part Number and Date Code**

**Step 6:** Verify the part number stamped on the inside release as **21396** and the date code is between (32U through 52U) or (01V through 24V). If it is, continue to Step 7.

If the part number or the date code is something other than **21396** and date code is not in the range listed above, this door is not included in this campaign, follow Step 10b and reassemble the existing door hardware.

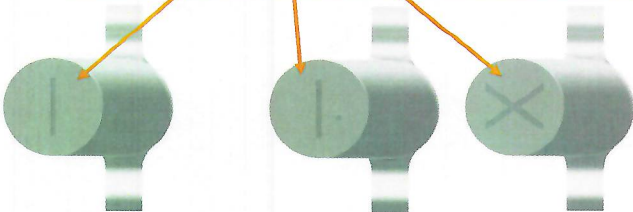
Inspect the end of the Connecting Rod. If there is a "-" mark on the threaded end, proceed to Step 7. If there is a "X" mark or a "-" AND a "." on the threaded end the hardware has already been updated, skip to Step 10b and reassemble the existing door hardware. No hardware from the kit will be needed.

Viewing the rod end requires fine attention to detail

Proceed to Step 7

Skip to Step 10b
