Rear Hatch Top Spoiler Contacting Roof Edge Or Flexing When Opening The Hatch Fully

Topic number	LI72.20-P-079685
Version	1
Function group	72.20 - Tailgate, rear door
Date	9/15/25
Validity	X247, X243 - EQB and GLB models
Reason for change

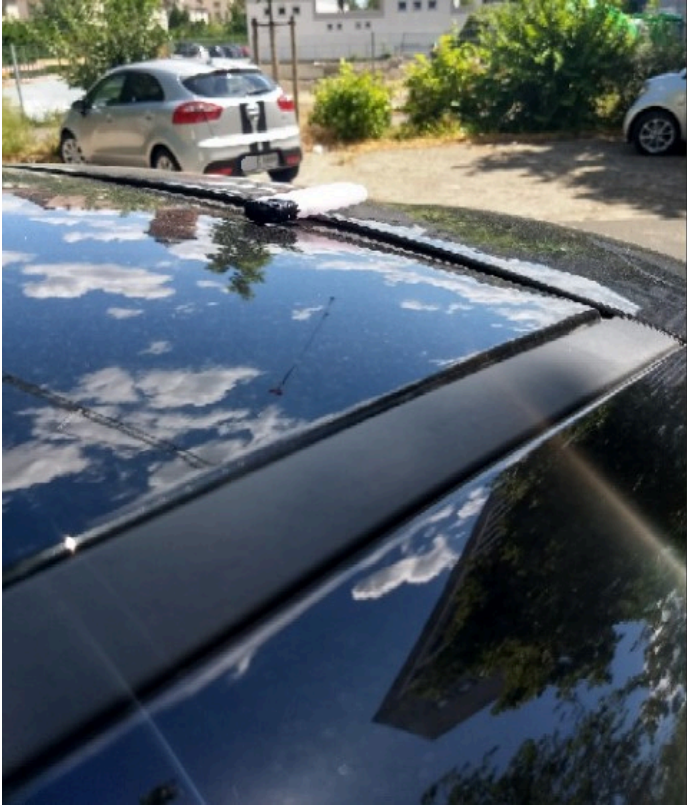
Bulging and contact of the rear spoiler when hatch is opened (picture 1-1). When opening the rear hatch, the rear spoiler rests at the roof edge, which can result in damage to the rear spoiler and roof if the hatch is forcefully opened when the rear spoiler is bulged over (picture 1-2).

Attachments	
File	Description
Bild 1-1.jpg	Bulging of the rear spoiler against the roof edge

In the event of higher outside temperatures, the spoiler of the rear-end door thermally expands and may be above the roof by several millimeters.

The cause may be related to fastening clips of the rear spoiler that have become loose.

Remove rear spoiler, replace all fastening clips. Install rear spoiler again. In the event of damage, repair the vehicle.

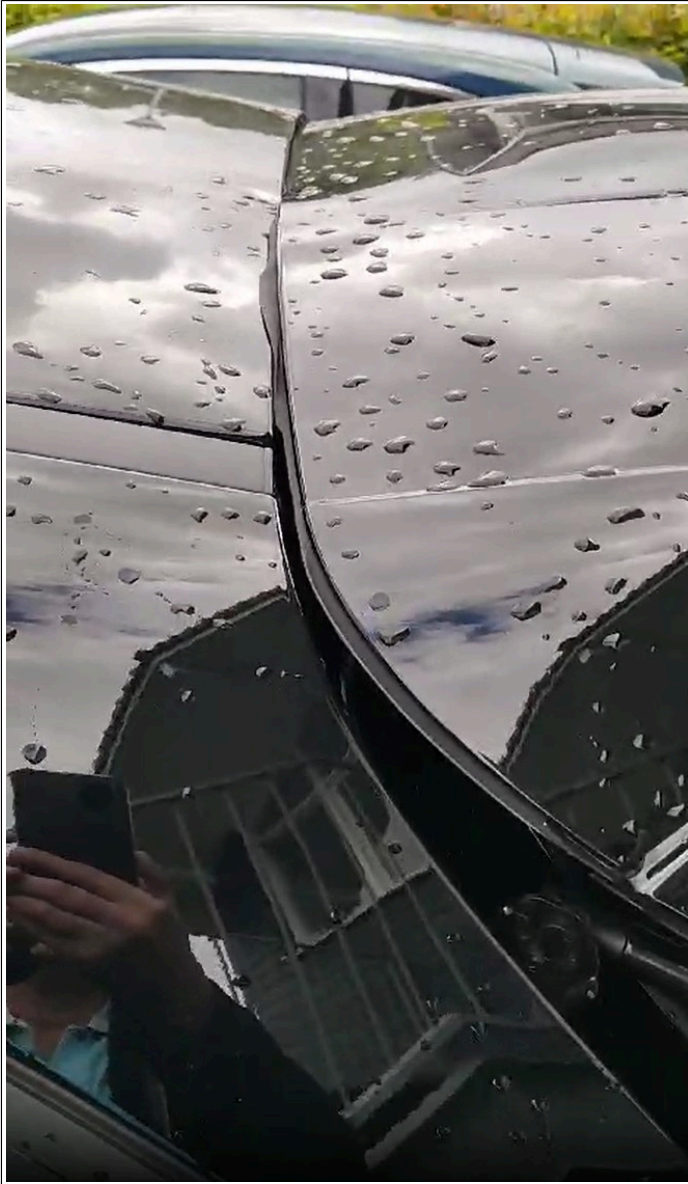
Bild 1-2.jpg	Rear spoiler collides with the roof edge and can cause consequential damage to the rear spoiler and roof edge

When opening the rear hatch when the rear spoiler is in a bulged condition, this can result in a collision between the rear spoiler and the roof edge.
