Service Bulletin

Bulletin No.: PIT5800D

Subject: Service Theft Deterrent System / SES MIL / Fuse F49DR Open / DTCs B113C B13AC B1AC3 B195D B195E U3018 U3501

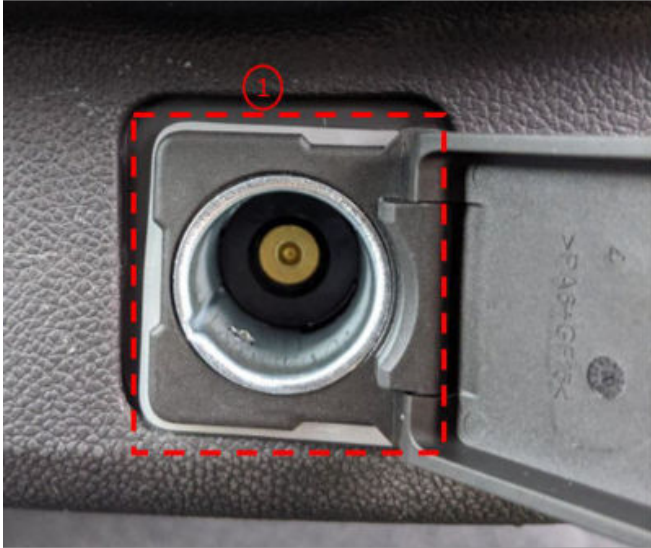
5672399

Involved Region or Country	North America
Condition	Some customers may comment on a SES MIL and a Service Theft Deterrent System message displayed in the DIC. When checking for DTC's, any of the following DTC's may be set: B113C, B13AC, B1AC3, B195D, B195E, U3018 and/or U3501. Also, fuse F49DR in the right IP fuse block will be open.
Cause	One possible cause of this condition is a short in the 12 volt power accessory illuminated ring. The 12 volt power accessory ports X80G or X80H have a LED illuminated ring around the perimeter (1), shown below. The LED illuminated ring is part of the 12 volt accessory port receptacle retainer, see 2nd photo. The 12 volt accessory port receptacle retainer has two contact tabs for the LED illuminated ring (2 and 3) which mate to the 12 volt accessory port receptacle (5 and 6), see 3rd photo. Tab 2 is for the power to the LED illuminated ring circuit 6817 and tab 3 is the ground which should only contact the outer metal body (6) of the 12 volt accessory port receptacle. If tab 3 is improperly formed or gets bent during service, it can short out between the metal body (6) and the slide contact (5) for tab 2, as shown below in call out 4. Tab 3 should only contact the metal body of the 12 volt accessory port receptacle (6).

Following SI, remove the 12 volt power accessory port X80G or X80H and inspect grounding tab 3. If the tab is shorting out between the metal body (6) and slide contact (5) for tab 2 then replace the 12 volt Accessory Power Port Receptacle Retainer.
