Trimark Entrance Door Latch

Bulletin Type:	TSB	Publication Date:	September 2025
Bulletin #(s):	25-004	Make(s):	Entegra Coach
Job Code(s):	9803627	Model(s):	Anthem, Aspire, Cornerstone, Cornerstone Reserve
Flat Rate(s):	9803627A .10 HR - Entrance Door Latch Inspection 9803627B .30 HR - Entrance Door Latch Inspection and Repair	Model Year(s):	2025 – 2026

Incident:	Exterior Entrance Door Lock-out
Affected Units:	2025 – 2026 Entegra Coach Anthem, Aspire, Cornerstone, Cornerstone Reserve
Parts Kit:25-004EC	Parts Kit #: 25-004EC
	Part Kit Contents: 1 - KIT,TSB 100-3100 RTROF TSB102
Misc. Tools & Supplies:	Refer to Instructions below
Parts Return Information:	Serial number of door

TRIMARK ENTRANCE DOOR LATCH INSPECTION

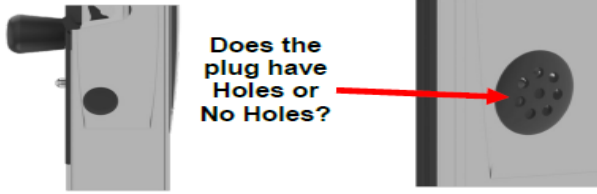
Step 1: Inspect the Black Plastic Plug on the door edge to see if there are holes on the top. If there are, the door hardware has already been upgraded, please disregard these TSB instructions.

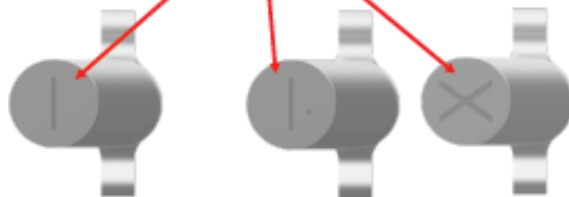
Inspect the end of the Connecting Rod. If there is a "-" mark on the threaded end, proceed to Step 7. If there is a "X" mark or a "-" AND a "." on the threaded end the hardware has already been updated, skip to Step 10b and reassemble the existing door hardware. No hardware from the kit will be needed.

Viewing the rod end requires fine attention to detail
