REFERENCE:	TSB: 08-302-25 GROUP: 08 - Electrical	Date:	September 12, 2025	REVISION:	-
VEHICLES AFFECTED:	2023 (W7) Jeep Grand Cherokee (INDIA) 2021 - 2023 (WL) Grand Cherokee / Grand Cherokee L (Australia) This bulletin applies to vehicles built equipped with one of the following radios: <ul style="list-style-type: none"> Uconnect 5 Nav w 8.4" Display (Sales Code UPL). Uconnect 5 Nav w 10.1" Display (Sales Code UPN). Uconnect 5 Nav W 8.4" Display (Sales Code UUL). Uconnect 5 Nav w 10.1" Display (Sales Code UUN). 			MARKET APPLICABILITY: <input type="checkbox"/> NA <input type="checkbox"/> MEA <input type="checkbox"/> SA <input checked="" type="checkbox"/> IAP <input type="checkbox"/> EE <input type="checkbox"/> CH NOTE: This bulletin applies to the India & Asia Pacific market.	
CUSTOMER SYMPTOM:	Customers may experience one or more of the following: <ul style="list-style-type: none"> Temperature displayed in the radio display screen and rear HVAC are mismatched. Auto door locks are inoperable.

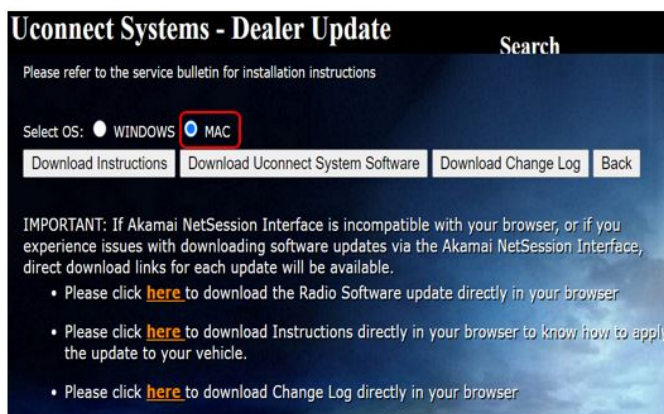
Fig. 1

MAC Download Steps

6. Download the software update file to your local PC's desktop. Make sure to select the “MAC” radial button for all downloads Fig. 1.

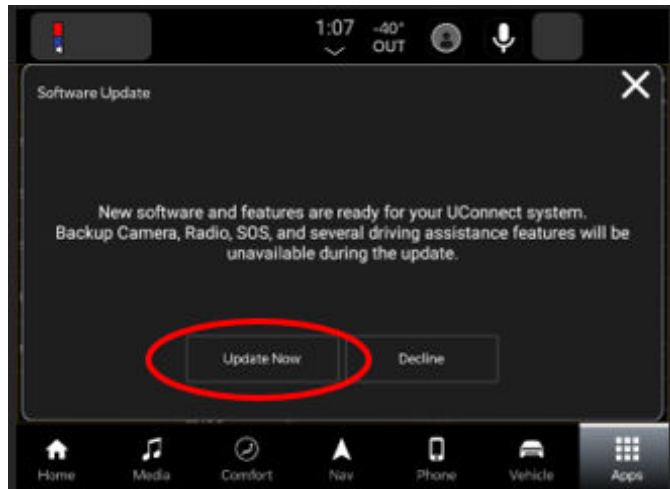
Fig. 2
Software Update Screen

13. Press Update Now [Fig. 2](#).

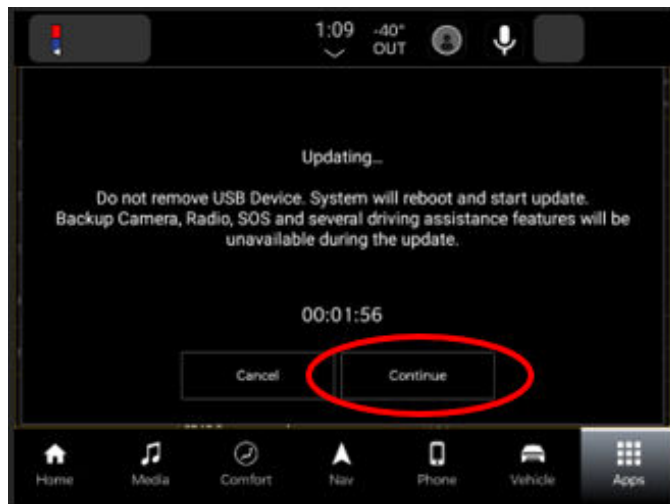
Fig. 3
Timer Screen

14. Press Continue [Fig. 3](#).

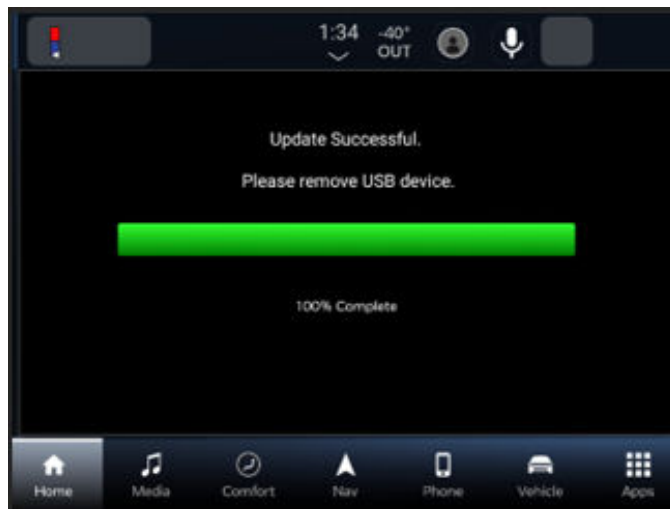
Fig. 4
Progress Screen

15. Wait for software update to complete 100% [Fig. 4](#).

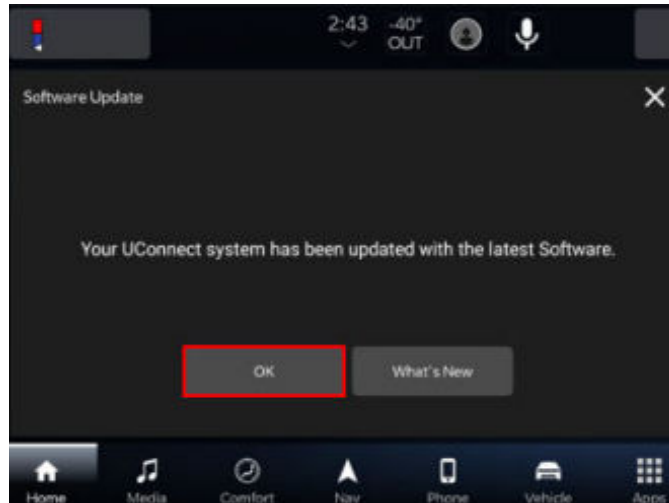
Fig. 5
Software Update Complete

NOTE: System update process takes approximately five minutes. Wait until radio restarts and Home screen is displayed [Fig. 5](#).

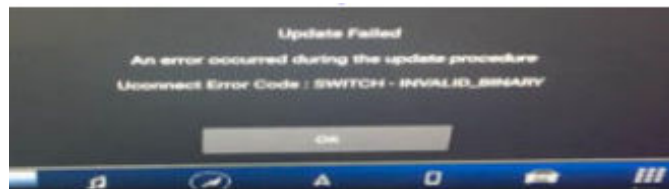
- Flash time will take ~30 minutes to one hour.
- Vehicle should be running the entire time.
- Sometimes the radio throws an error pop up "Switch-Invalid_Binary" after successful radio update. Please ignore this error and click OK [Fig. 6](#).

Fig. 6
Switch-Invalid_Binary Error
