**Technical Service Bulletin (TSB)**  
**Windshield Crack at Lower Edge**

<b>REFERENCE:</b>	<b>TSB:</b> 23-031-25 <b>GROUP:</b> 23 - Body	<b>Date:</b>	September 12, 2025	<b>REVISION:</b>	—
<b>VEHICLES AFFECTED:</b>	<b>2021 - 2023 (VF) RAM ProMaster</b> This bulletin applies to vehicles built on or after July 12, 2021 (MDH 0712XX) and on or before June 23, 2023 (MDH 0623XX).			<b>MARKET APPLICABILITY:</b> <input checked="" type="checkbox"/> NA <input type="checkbox"/> CH <input type="checkbox"/> EE <input type="checkbox"/> IAP <input type="checkbox"/> SA <input type="checkbox"/> MEA <b>NOTE:</b> This bulletin applies to the North America market.	
<b>CUSTOMER SYMPTOM:</b>	<b>Customers may comment on the following:</b> <ul style="list-style-type: none"> <li>A crack (or cracks) at the bottom of the windshield.</li> </ul>				
<b>CAUSE:</b>	Manufacturing defect

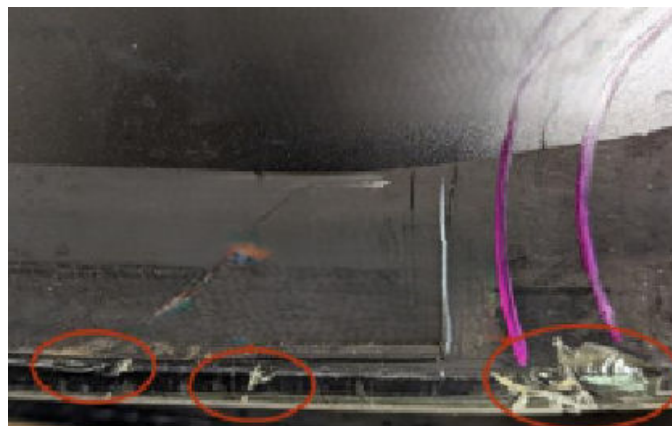
1. Inspect the windshield for cracks [Fig. 1](#).

**Fig. 1**  
Windshield Cracks

2. Are any windshield cracks present?
  - YES >>> Proceed to [Step 3](#).
  - NO >>> This bulletin does not apply.
3. Replace the windshield. Refer to the detailed procedures available in DealerCONNECT > Service Library> under: 23 - Body / Stationary Glass / Windshield / Removal and Installation.
