Technical Service Bulletin (TSB)
Key Fob Not Detected When Near Wireless Charger

REFERENCE:	TSB: 08-016-25 REV. C GROUP: 08 - Electrical	Date:	September 11, 2025	REVISION:	08-016-25 REV. B
VEHICLES AFFECTED:	2025 (DT) RAM 1500 Pickup This bulletin applies to vehicles equipped with a Wireless Charging Pad (Sales Code RFX) or Dual Wireless Charging Pad (Sales Code CMS).			MARKET APPLICABILITY: <input checked="" type="checkbox"/> NA <input checked="" type="checkbox"/> MEA <input checked="" type="checkbox"/> SA <input checked="" type="checkbox"/> IAP <input type="checkbox"/> EE <input type="checkbox"/> CH NOTE: This bulletin applies to the North America, South America and Middle East & Africa markets.	
CUSTOMER SYMPTOM:	Customers may comment on one or more of the following: <ul style="list-style-type: none"> • Vehicle may not start. • Key Fob intermittently is not detected when the key fob is placed at or near the wireless charger. 				
CAUSE:	Radio Frequency (RF) interference

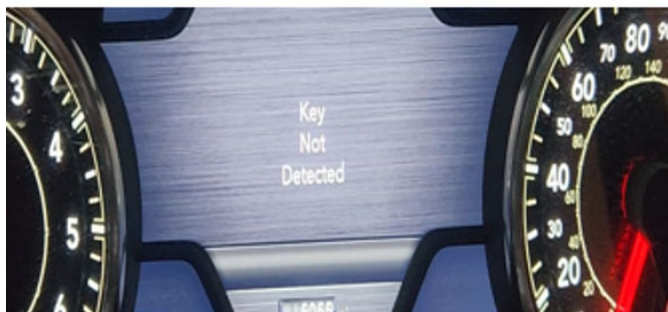
Fig. 1
Key Not Detected Message

- NOTE:**
- The key fob needs to be at least 203 mm (8 in.) away from the wireless charger and/or do not put a phone on the wireless charger before the ignition is ON.
 - When the ignition is OFF and the key fob near an active wireless charger, interference can occur leading to the key fob not being detected by the vehicle **Fig. 1**.

To verify if the vehicle has this Symptom/Condition, perform the following: Remove any phones from the wireless charger. Verify if the key fob functions/is detected now. **If key fob functions/is detected now, replace wireless charging Pad as required according to the Part Number Supersession table below.**
