## Seal Attached To B-pillar Trim On Rear Doors Cracked

Topic number	LI72.12-P-076175
Version	5
Function group	72.12 - Rear door
Date	9/15/25
Validity	MODEL 206 206.0 FIN "F" up to manufacturing date: 18.01.2023 206.0 FIN "R" up to manufacturing date: 23.02.2023 206.2 FIN "F" up to manufacturing date: 15.12.2023
Reason for change	Order from taskforce quality model series 206: If a problem is present on a page, the other page must also be replaced. This is intended to avoid a possible follow-up repair.

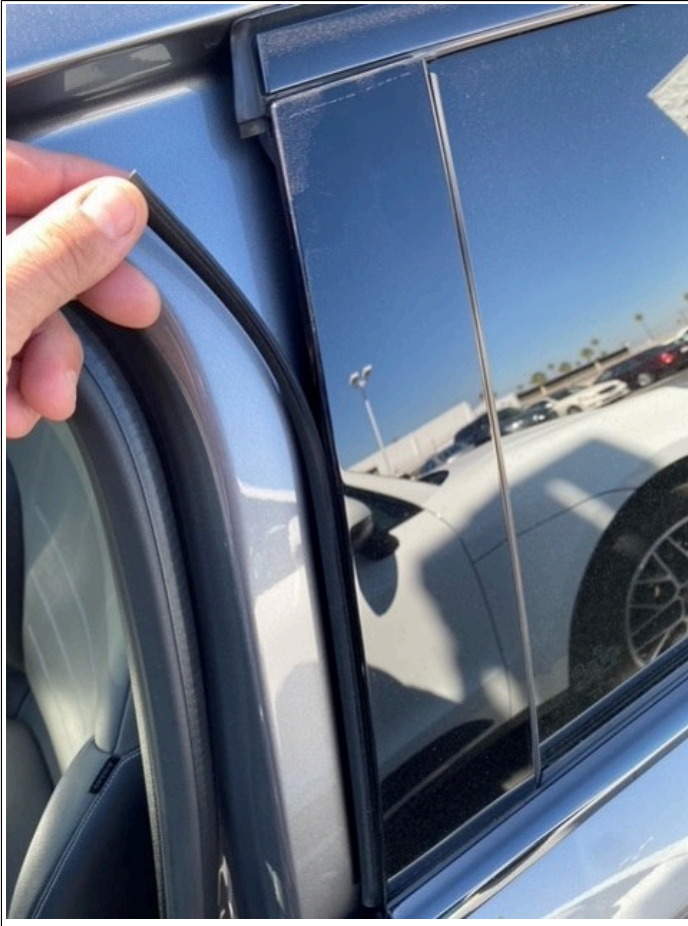
Attachments	
File	Description
Bild 1.jpg

Seal secured to B-pillar trim on rear doors cracked in upper area, see picture 1.

Production deviation at supplier of B-pillar trim.

Replace both B-pillar trims with optimized parts.

Both B-pillar trim pieces on the vehicle should be replaced, even if only one currently has the complaint.
