SIB 11 05 25

DELIVERY STOP: S68T ENGINE - REPLACE UPPER OIL PAN SCREWS

This Service Information Bulletin (Revision 3) replaces SI B11 05 25 [AM1] [MM2] dated August 2025.

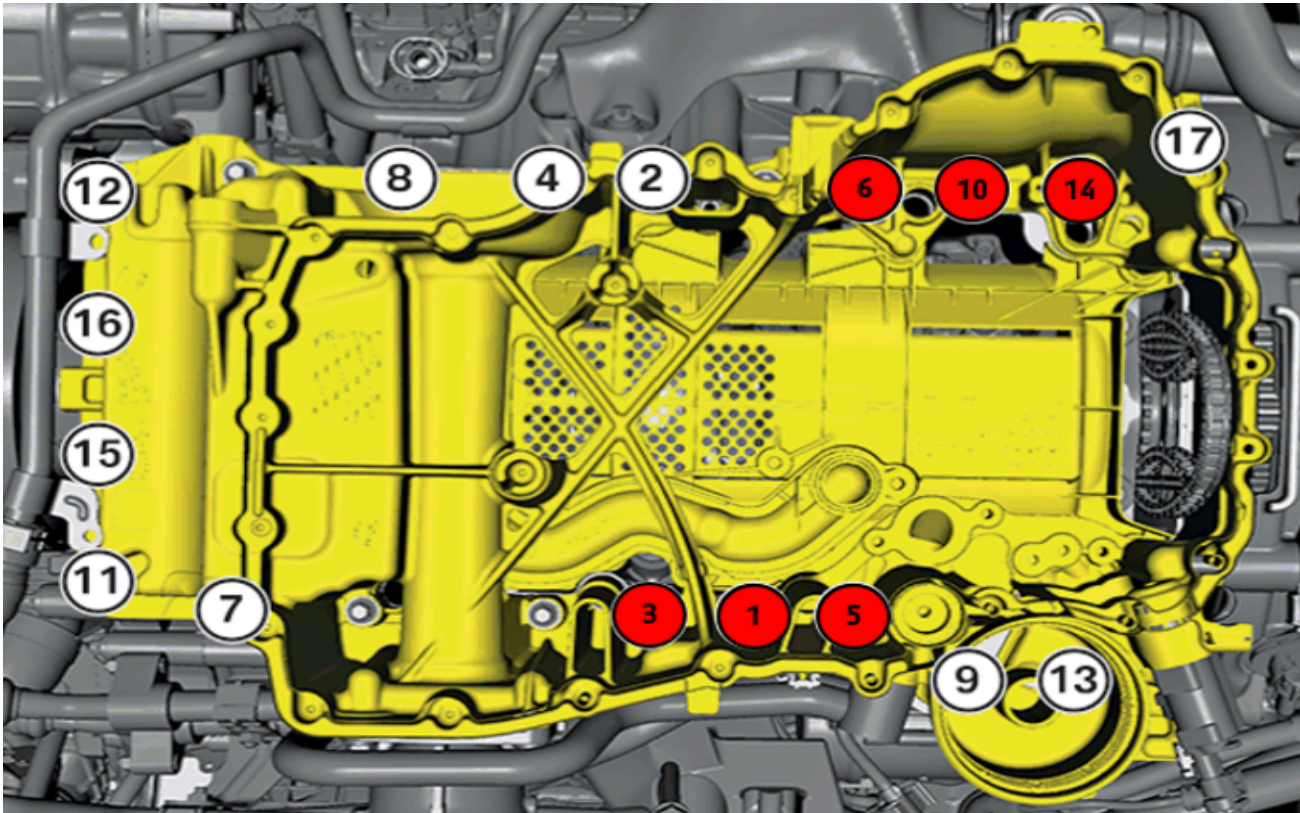
Due to an assembly error the upper oil pan screws may not have been torqued correctly.

2. Remove, replace and torque each screw **one at a time** using the sequence of numbers in the illustration below. Only replace the 6 screws highlighted in red.

Replace the 6 affected screws in positions 1, 3, 5, 6, 10 and 14 in that order only.

Torque the 6 new screws to the following:

**Joining Torque: 10 Nm**

**Angle Torque: 90 degrees**
