SIB 52 12 25  
CLICKING NOISE FROM SEAT BACKREST

2025-09-17

| E-Series | Model Description | Affected Option Code |
|---|---|---|
| U10 | X2 Sport Activity Coupe | Vehicles without lumbar support |

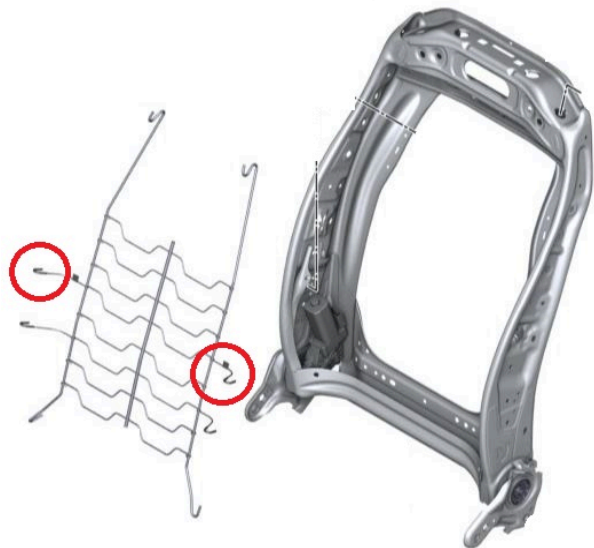
The hooks for the back support mat mounting spring move against the seat backrest frame.

Apply 2 cable straps per seat to lock the spring hook(s) so they can't move relative to the seat backrest frame. The cable straps are only required in the two locations circled in red.
