MODEL

| E-Series | Model Description |
|---|---|
| U10 | X2 Sports Activity Coupe |
| U11 | X1 Sports Activity Vehicle |

SITUATION

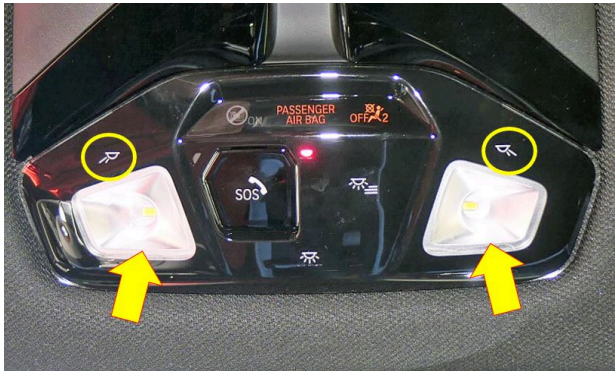
The front interior reading light(s) (arrows) will randomly turn ON and OFF while driving.

The reading lights are normally activated by touching the small icons (circled).

Soldering defects on the electrical circuit board of the reading light.

Replace the affected reading light assembly.
