## SIM 52 02 25 CLICKING NOISE FROM SEAT BACKREST

2025-09-17

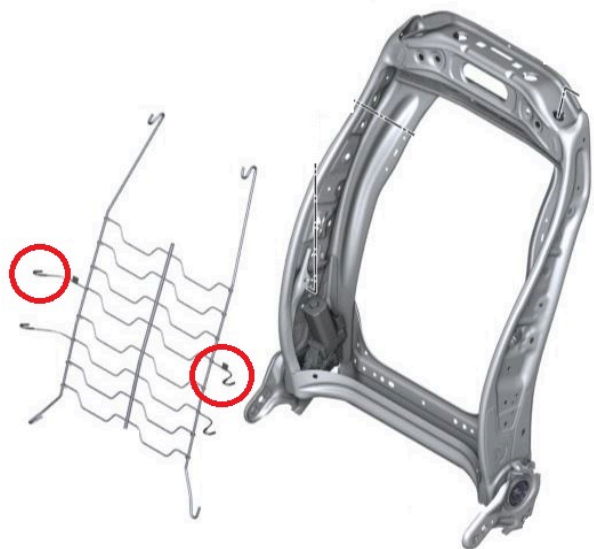
The hooks of the back support mat mounting spring move against the seat backrest frame.

Apply 2 cable straps per seat to lock the spring hook(s) so they can't move relative to the seat backrest frame. The cable straps are only required in the two locations circled in red.
