GROUP	MODEL
ELE	2023MY Sportage (NQ5a) w/ AVNT Head Unit
NUMBER	DATE
355 (Rev 1, 09/19/2025)	October 2024

## TECHNICAL SERVICE BULLETIN

### AVNT COAXIAL CABLE REPLACEMENT

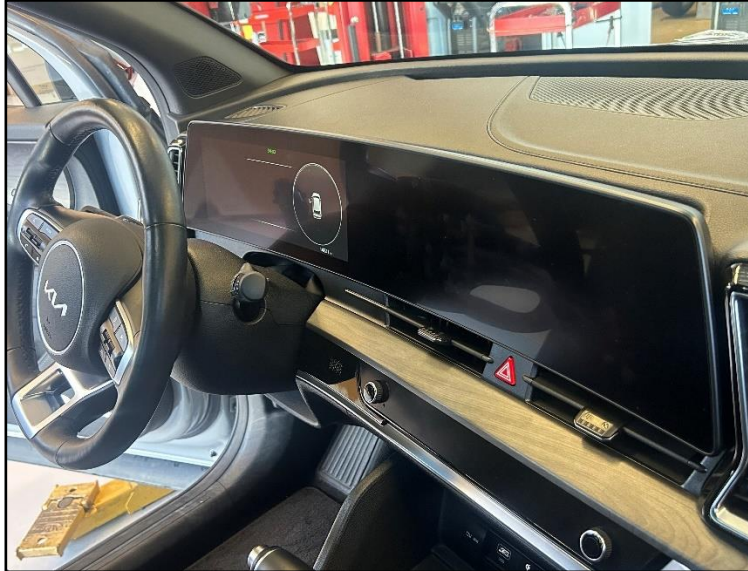
This bulletin provides the procedure to replace the Audio Video Navigation Telematics (AVNT) head unit coaxial cable on some 2023MY Sportage (NQ5a) vehicles produced from August 5, 2021 through May 25, 2023. The affected vehicles may experience the AVNT screen flickering 'ON/OFF' due to an intermittent contact of the coaxial cable connector with the AVNT head unit. Follow the procedure outlined in this publication to replace the AVNT head unit coaxial cable on the applicable vehicle.
