# TECHNICAL SERVICE BULLETIN

## Illuminated MIL And/Or Powertrain Malfunction (Wrench) Indicator With Various Diagnostic Trouble Codes (DTCs)

**25-2385**

Ford 2022 e-Transit
------------------------

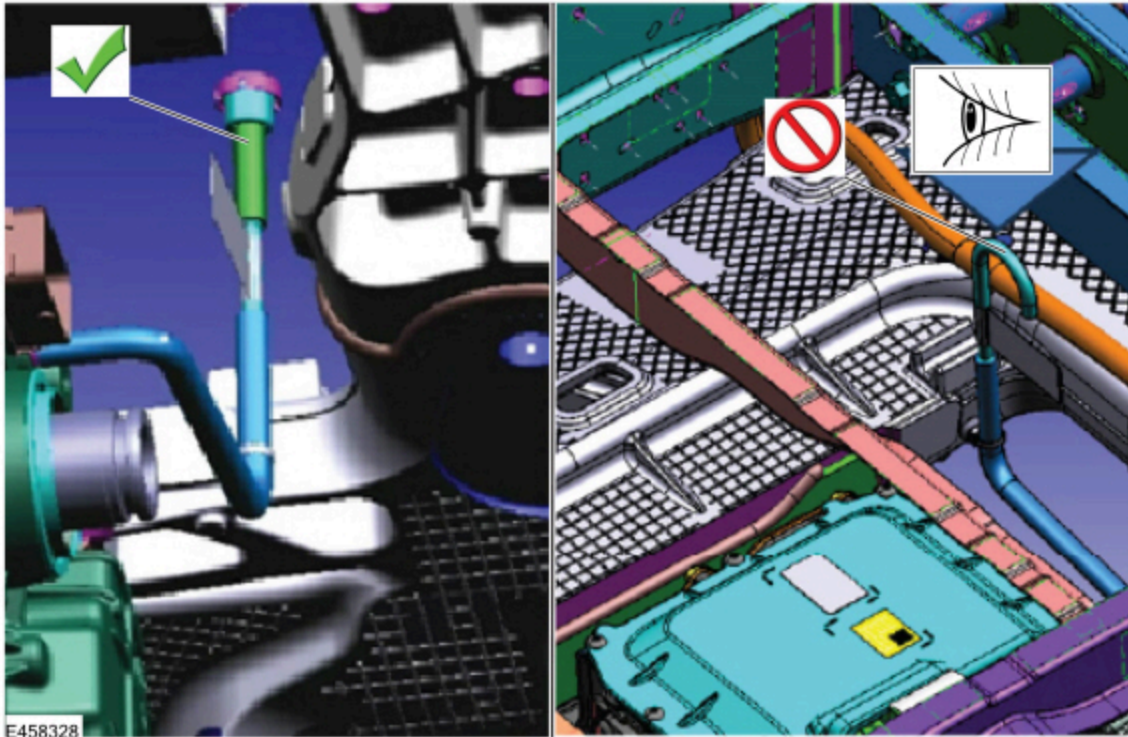
Figure 1

- Illuminated MIL and/or illuminated powertrain malfunction (wrench) indicator with DTCs P0711, P0A2B, P0A2D, P0A2C, P0712, P0713 stored in the SOBDMC.
- DTCs P0AA6, P1A10 stored in the IPC
- Equipped with early design vent assembly attached to rear electric drive assembly. Refer to Figure 1.

1. Raise vehicle to inspect the rear electric drive assembly unit vent. Refer to WSM, Section 100-02 > Jacking and Lifting.
2. Is the vehicle equipped with the rear electric drive assembly vent hose as shown in the image with the green check mark in Figure 1?

- (1). Yes - proceed to Step 4.
  - (2). No - proceed to Step 3.
3. Remove and discard the vent tube assembly and replace with updated part.
  4. Perform the "Drive Assembly Oil Draining and Filling". Refer to WSM, Section 302-02 > General Procedures.
  5. Clear DTCs.
