TECHNICAL SERVICE BULLETIN

Soft Top Material Wear Above B-Pillar

25-2439

Ford 2021-2022 Bronco	Soft Top
---------------------------------	----------

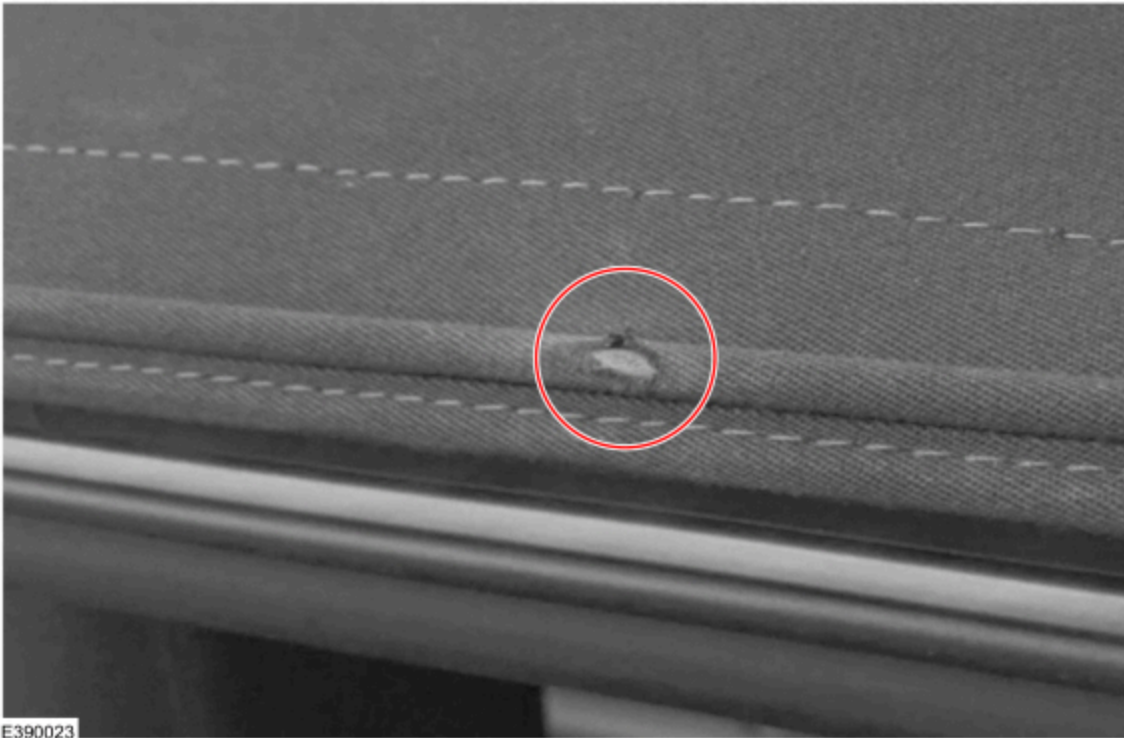
Figure 1

Issue: Some of the vehicles listed in the Model Statement may exhibit soft top exterior wear on the sides of the soft top material above the B-pillar. This may be due to contact and rubbing between the soft top frame and soft top material.

1. Does the soft top exhibit wear above the B-pillar similar to Figure 1?

(1). Yes - proceed to Step 2. Updated deflectors will be installed on both sides of the soft top frame assembly to prevent wear.

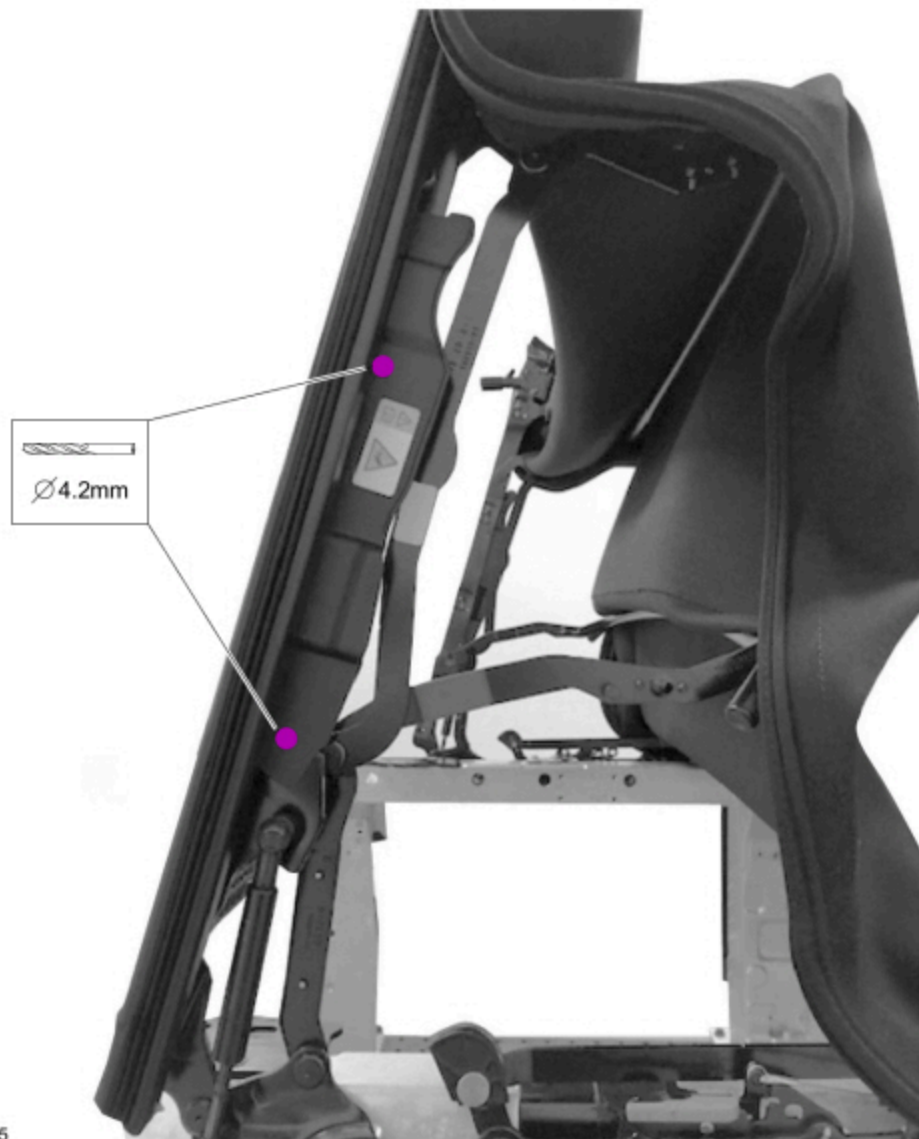
Figure 3

⚠ CAUTION: Do not drill through the linkage assembly. Only the head of the rivet should be drilled. Drilling through the linkage enlarges the hole where a new rivet will not fit to secure the linkage.

4. Locate each deflector on the right and left side of the frame assembly and drill out 2 rivets per deflector using a 4.2 mm (11/64 in) drill bit. (Figure 3)
